Slope Stability Evaluation and Monitoring of a Sandy Bluff on the Shoreline of Lake Erie

Hugh Gillen and Brennan Bailey
DST Consulting Engineers Inc., Waterloo, Ontario, Canada
Farbod Saadat
DST Consulting Engineers Inc., Mississauga, Ontario, Canada

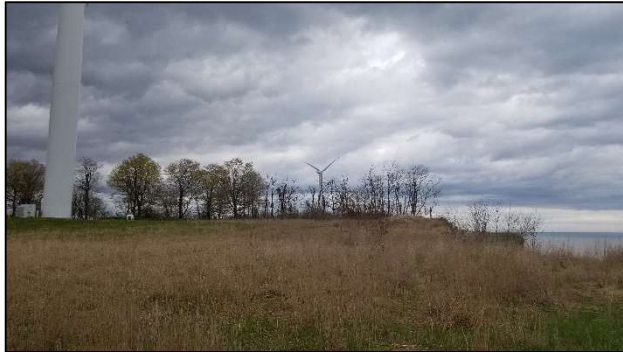
In 2019, a geotechnical investigation and slope stability evaluation were conducted for a shoreline property featuring a wind turbine and a steep 24-m high bluff. The wind turbine had been constructed more than a decade ago and earlier shoreline erosion studies were originally used to determine the offset from the historical shoreline. By May 2019, the 80-m tall turbine was only 60 m from the edge of the bluff (see Figure 1), leading to concerns regarding its continued safe operation.

Figure 1. Wind turbines can be seen along the coast of Lake Erie, with the top of the bluff visible nearby.

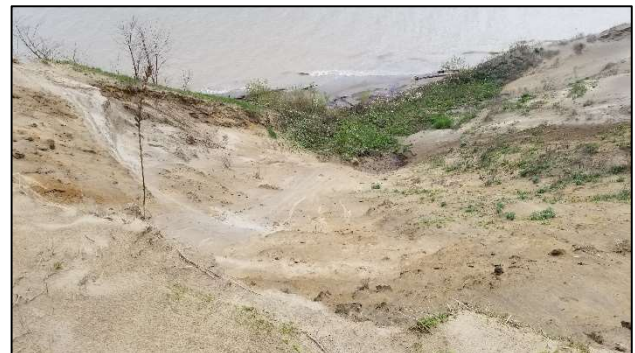
The cliff-side was examined from a safe distance during this site reconnaissance visit. A surficial layer of sand was observed overlying an apparent siltier unit, visually estimated at approximately 6-8 m below ground surface (mbgs). Seepage was visible at the interface between the two units, likely from groundwater perched on top of the less permeable (assumed) silty unit. A conical slide scarp was observed at the bluff face, as shown in Figure 2.

Figure 2. View of the bluff face from which seepage can be seen discharging. Limited vegetation is visible at the toe, along with downed trees.

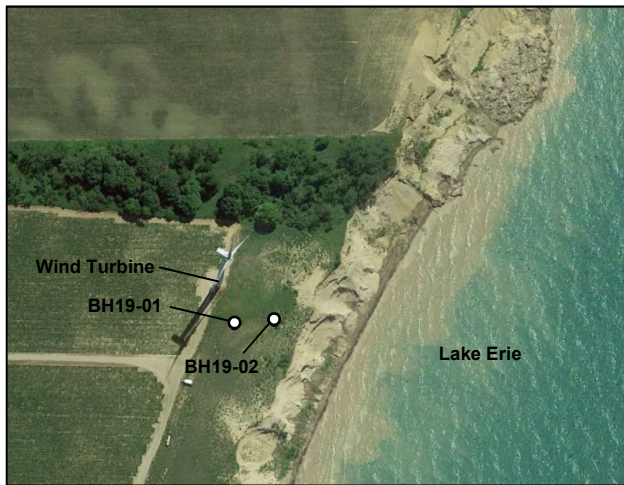
Two geotechnical boreholes, designated BH19-01 and BH19-02, were advanced at the Site in July 2019. The boreholes were located approximately 42 m and 20 m from the top edge of the bluff, respectively, and roughly in line

with the turbine and the bluff (see Figure 3). Split spoon soil samples were obtained and logged as the boreholes were advanced. BH19-01 and BH19-02 were terminated at depths of 31.1 (el. 167.5 masl) and 35.7 mbgs (el. 162.5 masl), respectively.

Figure 3. The wind turbine and the boreholes are shown at the study site near the coast of Lake Erie, with recent instabilities visible along the shoreline bluff.

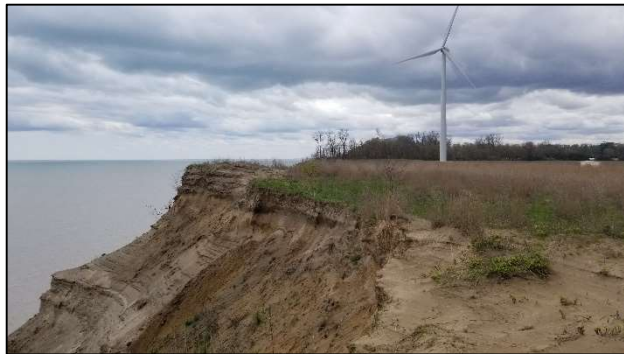
Figure 7. The shape of the bluff face can be seen in this side view photo taken during the initial site visit. Another turbine can be seen in the background.

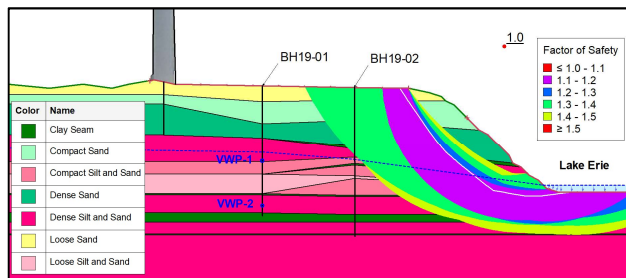
As expected, incorporating potential soil suction into the model had a favorable effect on the computed FOS. The FOS for the critical slip surface increased to 1.0, representing a short-term pseudo-stable condition. The model output is shown below in Figure 8.

Figure 8. Preliminary slope model incorporating the contribution of soil suction.

Incorporating the contribution of soil suction in the model yielded a positive effect on the apparent global stability of the bluff that cannot be relied on over time. It is expected that a rainfall event during the wet season could temporarily reduce or eliminate potential soil suction by bringing the subsoils closer to a saturated condition. This supported the possibility that the landsliding could be triggered primarily by rainfall events.

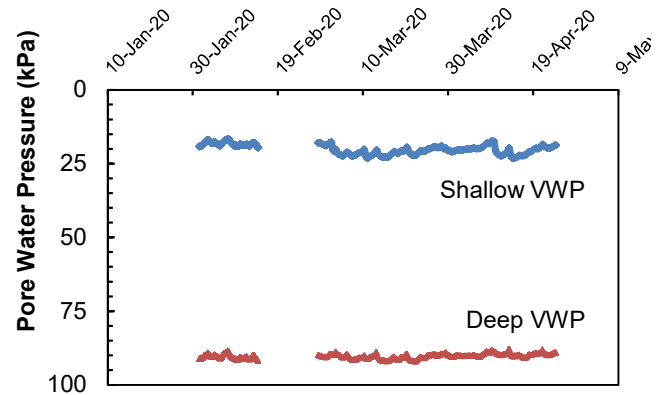
The shallow and deep VWP recorded porewater pressures that correspond to a computed water level of about 16 mbgs and 19.5 mbgs, respectively. The discrepancy between the porewater pressures recorded by the two VWP is believed to be a result of hydraulic isolation between layers, caused by the clay seams identified at depth. It was noted that the porewater pressure recorded by the deep VWP corresponds to a lower computed water level than the shallow VWP. The deep VWP was installed at an elevation of about 170 masl, while the water level of Lake Erie is expected to be about 175 masl. Hence, it was concluded that a perched water table condition must be present and affecting the porewater pressure being recorded by the shallow VWP. The existence of a perched water table is not unexpected, considering the presence of clay seams identified during the drilling program and the visual observation of seepage discharging from the midslope level of the bluff face. This conclusion was further supported by an observed divergence between the two computer water levels in the spring months, when increased groundwater volumes might reasonably be expected to result in a greater column of perched water.

The porewater pressure data collected in 2020 are shown below, in Figure 9. The recorded porewater pressure did not vary substantially over time, although several small peaks can be identified throughout the spring. These spikes are more evident in the shallower VWP data (shown in blue) but are still discernible in both.

Figure 9. Porewater pressure recorded in 2020.

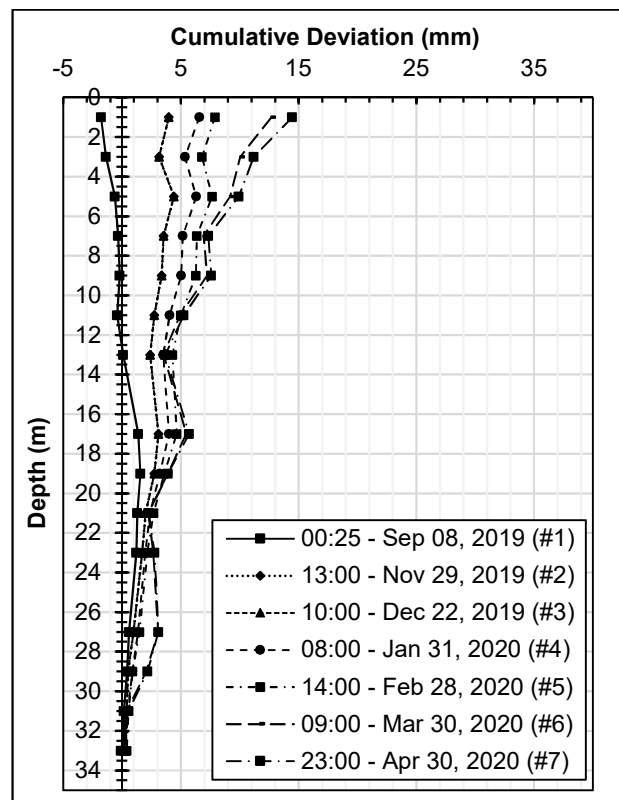
After nine months of monitoring, almost 15 mm of cumulative displacement at ground surface was recorded by the IPI (see Figure 10). The initial alert threshold of 10

mm was exceeded in March 2020, at which time the slope conditions were visually examined and subsequently the threshold was increased to 20 mm. To date, the cumulative rate of displacement at surface has averaged approximately 21 mm/year. This rate of displacement is considered Very Slow, as per the definitions proposed in the Varnes landslide velocity classes. Up until February 2019, a rate of 17 mm/year had been observed, suggesting the spring thaw has resulted in a slight increase in the rate of movement.

Figure 10. Incliner data in A-Axis direction (toward Lake Erie) showing movement recorded to date.

The ground movements recorded to date suggest the slope is exhibiting surficial creep, as evidenced by the slow but consistent increase in cumulative displacement near surface. At depth, a small degree of movement (less than 6 mm) has also been recorded but there is no concrete evidence of discrete slide surfaces at this point in time. Hence, the theory that sliding might be occurring along the clay seams appears to be unlikely based on this data.
