## Community Surficial Geology and Geohazards Map Series, Fort McPherson, Northwest Territories, Canada

Rita I. Kors-Olthof, P.Eng., P.E., Vladislav E. Roujanski, Ph.D., P.Geo.  
*Tetra Tech Canada Inc., Yellowknife, NT and Edmonton, AB, Canada*  
Shirley J. McCuaig, Ph.D., P.Geo.  
*SNC-Lavalin Inc., Edmonton, AB, Canada*

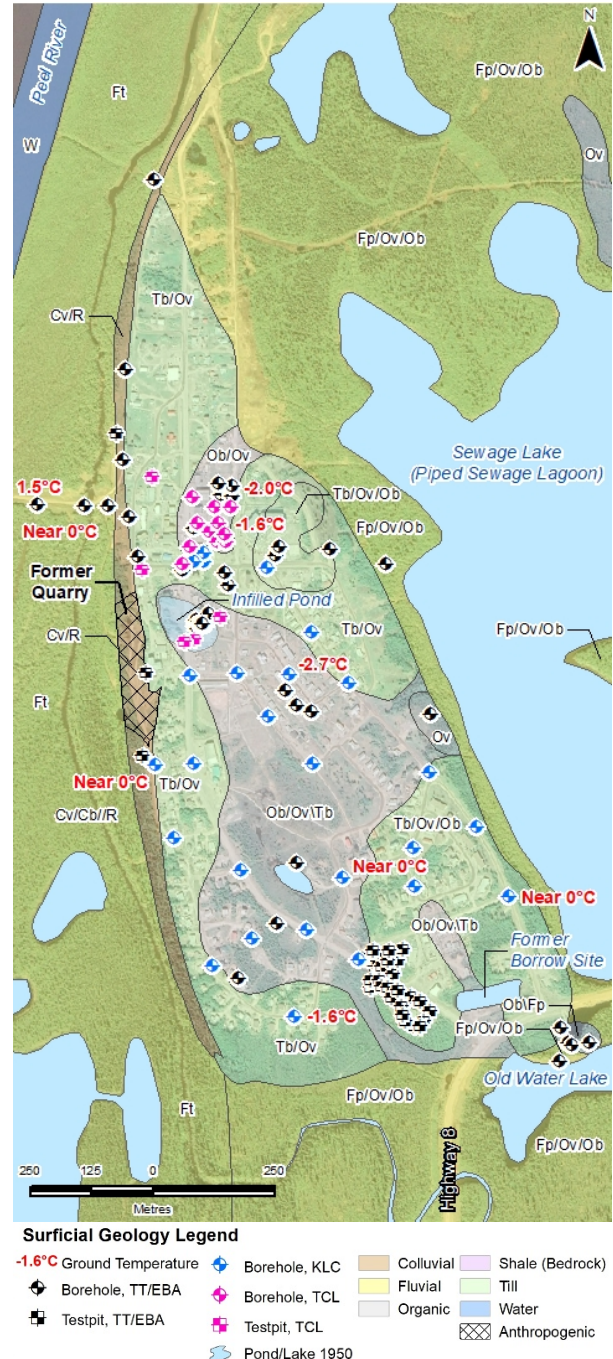
River, as shown in Figure 2. A steep slope on the upland's western side is covered with colluvial deposits of unknown thickness. The mapping was further refined by using the information from previous geotechnical site investigations and the data from the site investigation for this study. Testhole locations, including those executed for this study, are shown in Figure 2.

Figure 2. Surficial geology mapping, Fort McPherson, NT.

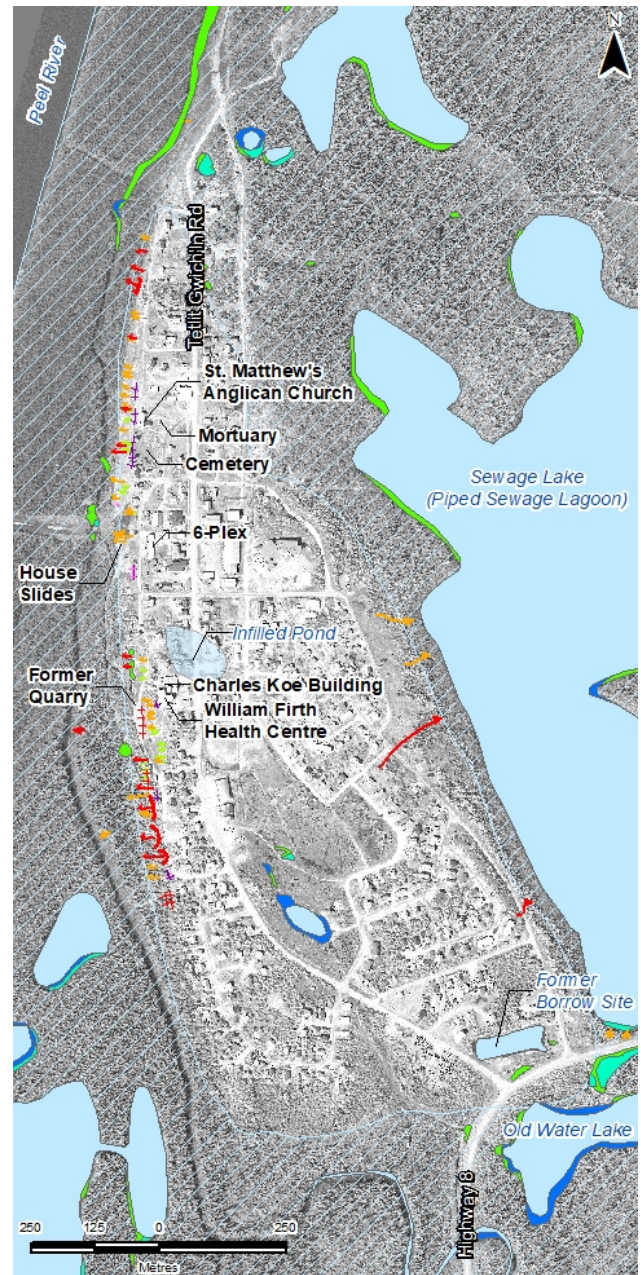
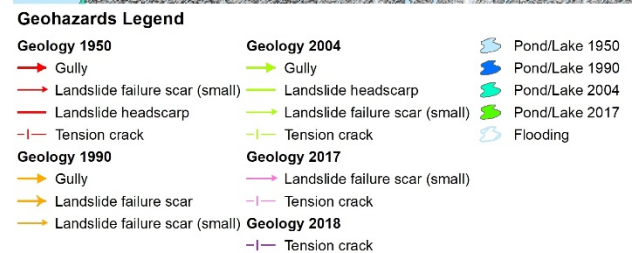
Between 1950 and 1990, the creek south of town expanded somewhat, but a number of lakes and ponds within and surrounding the townsite mapping area did not expand at all (Figure 3). Those that did grow, expanded mostly on the southern shore, by amounts of 10 to 22 m, perhaps due to prevailing northerly winds in summer resulting in extra wave activity that caused thermal erosion of the southern shores. A 22 m expansion over 40 years amounts to an approximate widening of about 55 cm/year.

From 1990 to 2004, lake expansions were on the order of 10-12 m, and directions of expansion were more random (Figure 3). Rate of widening was approximately 79 cm/year for this shorter time frame. Again, some lakes did not expand at all, and the majority of those that did are located on the Peel River floodplain deposits. This may indicate that the floodplain sediments are more ice-rich than the till uplands. The findings of EBA (1977) appear to corroborate this, as ice layers were found within the floodplain deposits. However, other studies indicate that the till uplands can also contain ice-rich layers or massive ice (KCL 1978; EBA 1992).

In 2017, river water levels were high – a tributary on the sand bar north of town appeared to be bank-full for the first time. Some of the apparent stream expansion south of town at this time may simply have been due to high water conditions. Some lake expansion occurred between 2004 and 2017. Expansions of about 10 m occurred mainly on the southern and western sides of the lakes in the floodplain zone (Figure 3). The widening rate was similar to the rate in the previous time frame, at about 77 cm/year.

Flooding can occur anywhere within the Peel River floodplain and, to a lesser extent, in areas of thinner fluvial deposits. Potential flood zones are shown on Figure 3. Disturbances including mud deposits and possible scouring along the slopes as a result of flooding were visible in some areas on the 2012 satellite image (Figure 4). The creek at the toe of slope on the western edge of the community is connected to the Peel River south and north of the community. It acts as an overflow channel during high water.

Figure 3. Geohazards mapping, with imagery from 2017.

Fresh debris slides were seen on the slope at the western edge of the town in 1950 (north end of current town extent, Figures 3 and 4). The remainder of the mapped debris slides and some possible tension cracks were vegetated and therefore formed at some time prior to 1950 (Figure 3).

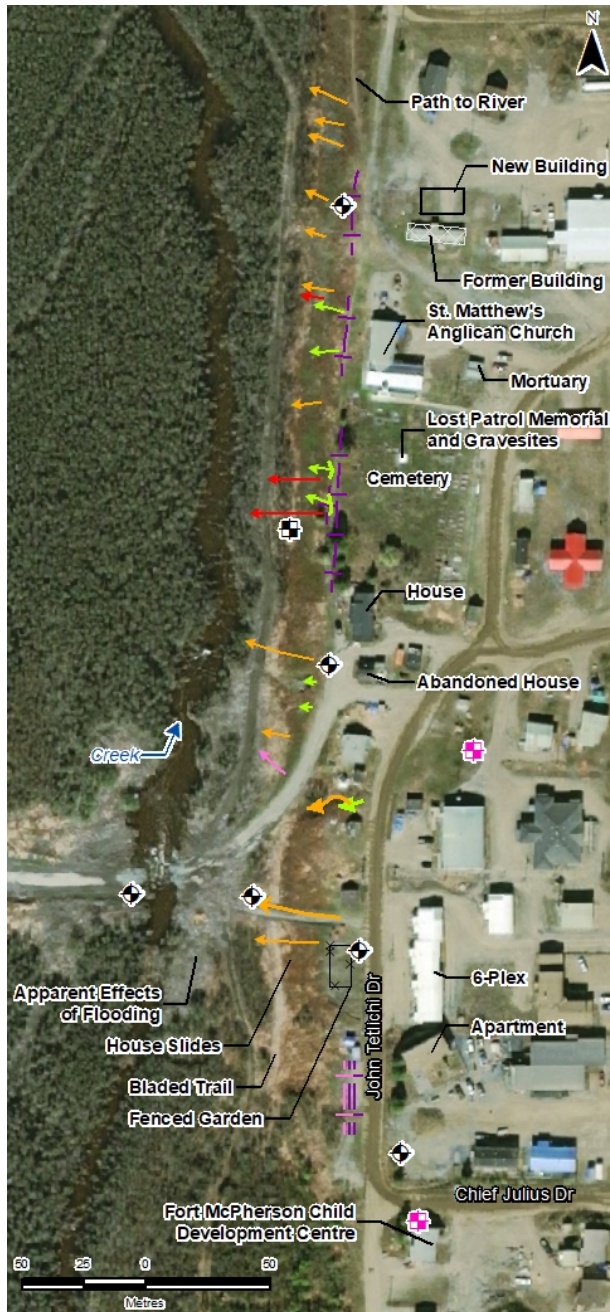
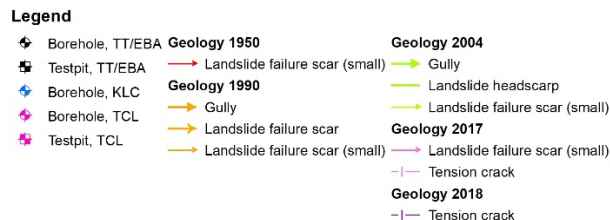
Gullies are natural features formed by water erosion. These are shown on Figure 3. Figure 4 shows an enlargement of the north end of the townsite. Most of the gullies are located on the steep slope along the western

Figure 4. Geohazards mapping, north end of townsite, with 2012 satellite image as background.

Two apparent debris slides, on either side of and below a house (marked "House Slides" on Figure 4), might once have been trails, based on a 1930's oblique photo (Figure 7). There was so much anthropogenic disturbance on the 1990 air photos that human clearing and construction activity might well have obscured other possible debris slides.

By 2004, there was a new debris slide on the slope below the north end of St. Matthew's Anglican Church, notable due to being unvegetated (Figure 4). The section of the slope between the main river access road and the north end of the church appeared to be exceptionally active, with slides observed on all years of air photos reviewed. All other newer debris slides visible in 2004 were vegetated, except below and above the road descending the slope in the former quarry in the south part of town (Figures 3 and 4). The northerly of the "House Slides" had become an obvious trail by 2004, while the southerly slide appeared to have mostly grown over (Figure 4).

The cleared area marked as a "bladed trail" on Figure 4 was an active snowmobile trail in the winter of 2018-2019. However, a date for possible clearing or earthmoving in this area was unknown, and the feature could also be scour-related. Tension cracks were noted upslope of this area.

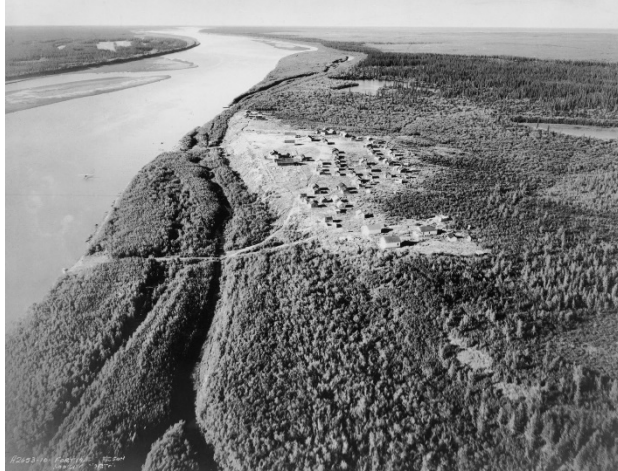
The general lack of trees below the church grounds appeared to be due to tree-cutting and brushing before the 1930's, as well as ongoing slope instabilities.

Figure 7. Looking north towards Fort McPherson in the 1930's. Note apparent removal of trees and shrubs in and below the developed part of the community, and the locations of overflow/creek channels in the floodplain. (Photo credits: Glenbow Archives NA-3844-92; or National Air Photo Library A2653-10; used with permission.)

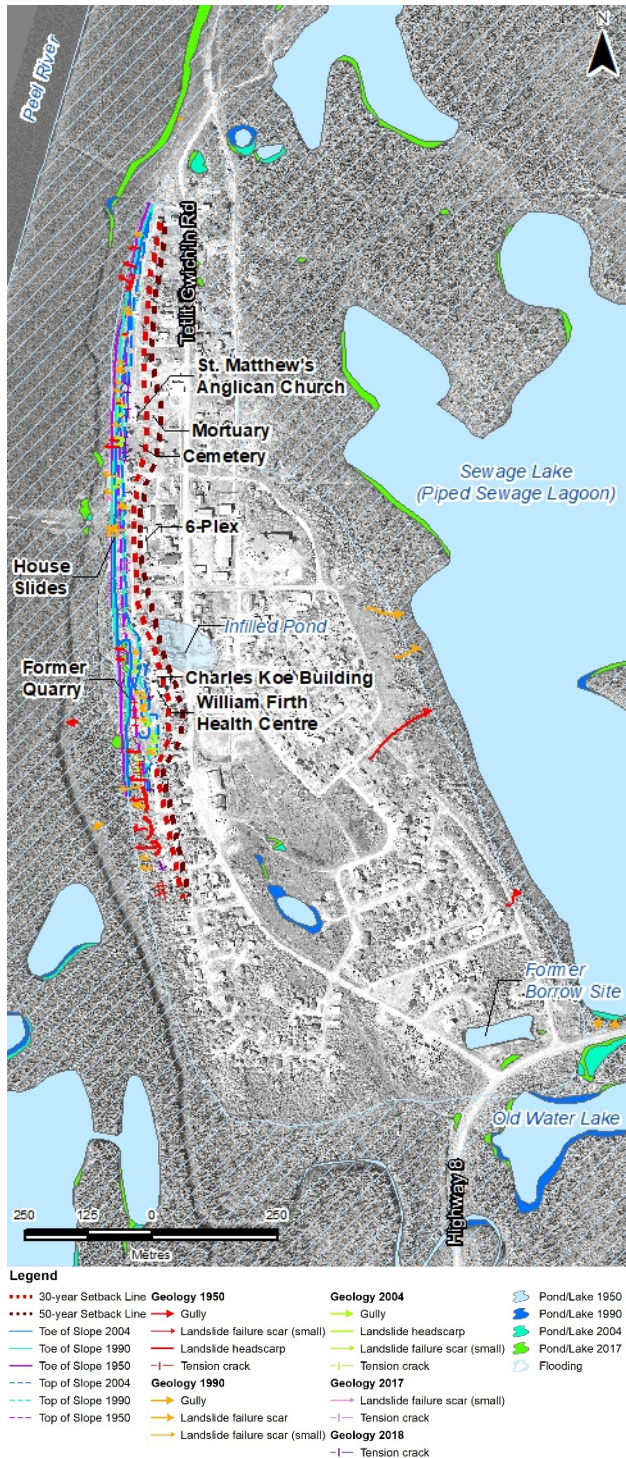
Nehtruh-EBA conducted a qualitative slope stability assessment for the steep slope along the western edge of the community (Figure 8). Slope stability was evaluated based on the historical air photo/satellite image review, slope characteristics based on topographic mapping, measured slope angles at selected locations, and observations of soils in shallow boreholes at selected slope locations and in previously-drilled boreholes near the slope in the community. Exposed soils were logged at selected slope locations: two sites in the upper slope at observed slope instabilities, and one site at the toe of slope where the slope was likely undercut by high river flows or floodwater.

Figure 8 tracks the changes in slope crests and bases, showing the toe and top of slope lines used for analysis, for the three sets of air photos (1950, 1990 and 2004) for which stereo coverage was available. These mapped locations, along with topographic data from the Government of Northwest Territories, Department of Lands (2018), were used to estimate approximate rates of slope retrogression for representative slope sections.

Figure 8. Visual Slope Retrogression Analysis and Recommended Setbacks.

Based on the estimated rates of slope retrogression, the recommended 30-year and 50-year setback lines were developed for use in land use planning (Figure 8).

- Gradually move at-risk structures further away from the slope as the buildings reach the end of their service lives, replacing them with buildings in safer locations;
- Move serviceable but at-risk structures before the end of their service life; and
- Prevent the construction of new buildings within at-risk areas.
