Stabilization of Rail Track, CN Dundas Sub, Dundas to Copetown, Ontario

Colin Alston, P.Eng.
Alston Geotechnical Consultants Inc, Markham, Ontario
Mario Ruel Ing,
Consulting Engineer
Melissa Ruel Ing,
CN Rail

ABSTRACT

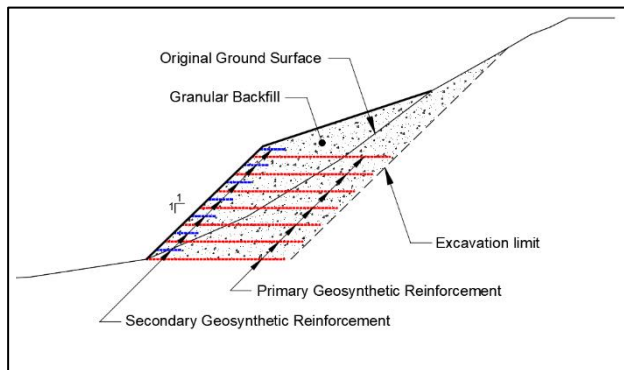
Figure 2. Cross section of reinforced soil slope

There is an approximately 12 m high embankment side slope at the study site which rested at a slope angle of about 35° to the horizontal. Settlement effects had been occurring over a track length of about 30 m. Prior to undertaking stabilization work, ongoing settlement at track level had been experienced over a period of several years and was increasing. Also, a site reconnaissance showed that a distinct toe bulge had developed at the toe of slope. The limits of the railway right-of-way lie at the toe of the existing embankment. Private homes lie adjacent to the property line. Geotechnical exploration showed that the embankment fill consists of sand with a variable gravel

fraction; also included in the fill are ash and cinders, and seams of silty clay. Based on in situ test results consisting of standard penetration tests, soundings carried out with a Marchetti Flat Plate Dilatometer, and dynamic cone penetrations tests, the friction angle of the mainly granular embankment fill materials is in the range of 27° to 30°, and the undrained shear strength of the included clayey seams was interpreted to be about 25 to 30 kPa. Adoption of these soil parameters in conventional analysis showed that the slope didn't have factor of safety as per today's standard at the time of construction. Since that time, the increased train loads have, in turn, reduced the margin of stability. Analysis of the stability of the slope supporting rail traffic showed that if the lower portion of the existing slope material could be replaced with engineered fill exhibiting a high friction angle, the factor of safety of the slope with respect to global stability could be sufficiently improved to provide a stable platform at the slope crest (Alston, Ruel, 2017). The project design requirement could be met by construction of a berm featuring high quality granular materials stabilized with geosynthetic reinforcement (Task Force 27, 1990; TRB 1987) to provide a stable, oversteepened slope.

To maintain rail operations, careful review of possible construction methodologies showed that if construction could be effected in a set of short sections, with each of these sections being closed up at the end of the day, digging of excavations in the existing slope was feasible. A small storage area could be utilized at one end of the work area. The closest point of access was at the crossing 2 km east of the site and from that point, fill materials required for berm construction would be transported along the tracks in dump trucks, and to the base of slope from track level by an access road constructed on the side of the rail embankment. Preparation for construction required careful preplanning; geotechnical supervision of site work was carried out by a very experienced geotechnical technician. A slow order of 10 mph was imposed on rail traffic for the duration of construction. The work was carried out without inducing any significant sliding in the construction excavations, there was no significant settlement experienced in the track in the course of construction. The constructed berm has arrested the ground movements at the site.

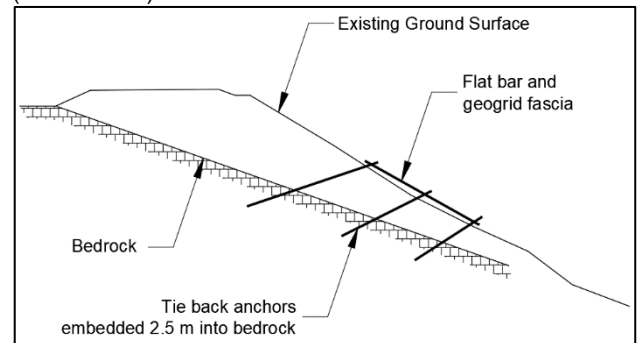
Figure 3. Cross section of tie bank anchors and flat bar / geogrid fascia

Relatively small settlement effects were being experienced over a section of track which was about 15 m long, over a period of years. An approximately 10 m wide slide in the dipping side slope on the north side of the tracks occurred immediately following a significant rainfall event. The depth of the slide and the proximity of the head of the scarp to the rail tracks required priority attention. Geotechnical explorations were carried out which showed that the rail track had been constructed on a platform which has been partially cut into a hillside, with excavated fill material being cast onto the slope on the downhill side. Rockhead was at shallow depth and dipped to the north at an angle of about 20° to the horizontal. The supporting slope exhibits a side slope gradient of about 35° from north to south and is about 12 m high. The downward slope continues beyond the property line, at a flatter angle. There is no adequate work staging area at the site.

The side slope fill consists of granular materials which lie on a layer of firm silty clay, which in turn rests on a sloping rockhead. Analysis of the site situation showed that occurrences of ground movements occurred intermittently at times of heavy precipitation.

Geotechnical exploration showed that the track platform is underlain by soft to firm becoming firm, plastic silty clay which in turn rests on sloping bedrock; the near surface sub-unit of the bedrock is heavily fractured and is relatively permeable. Geotechnical explorations also confirmed that the rail platform had been widened on the downhill side by casting excavated soil. Stability analysis showed that a modest increase in phreatic pressure in groundwater in the bedrock layer was sufficient to decrease the factor of safety to the point of causing straining movements in the overburden slope soil. Evaluation of design alternatives and consideration of space restrictions showed that stabilization could most efficiently be provided by installing a set of tie backs from the slope of the existing embankment, which tie banks extend from the embankment face into the bedrock stratum. Transfer of downslope loads resulting from ground movement to the tie back anchors was effected by a system incorporating laying a geogrid sheet on the slope surface through a network of flat steel strips which were in turn attached to the tieback anchors. The design slope covering is flexible, allows winter heave to occur without distress, and permits efficient drainage through the facing (Alston 1991).

Construction was carried out using a drill rig mounted on the slope face. The drill rig was held in position on the slope by attaching the rig to anchors installed at the slope crest with a set of cables. All equipment and supplies were taken to the site along the tracks from an access point located 1.5 km west of the study site. The constructed slope reinforcement has successfully arrested slope movement.

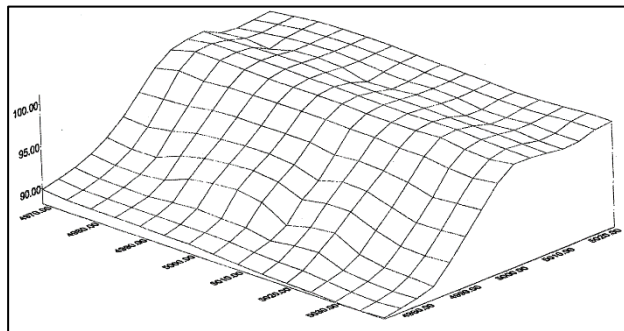
Figure 4. Isometric view of slope illustrating toe bulge

The affected section of track is about 40 m long and consists of a slope which rises to the north of the tracks and falls to the south, at a slope angle of about 30°. The rail platform has been cut into the slope, casting of spoil from the northerly (high side) cut onto the southerly, lower slope. Placing of the excavated spoil increased the slope angle to about 35°, the affected slope is about 10 m high. Ongoing attention and maintenance have been required prior to implementing remedial work. The boundary of the right-of-way lies above the toe of slope on the south side of the tracks; private properties line the right-of-way. The soil profile consists of about 2.5 to 3 m of loose sand overlying firm silty clay. Rockhead lies at a depth of about 5 m. Groundwater is present at the base of the surficial sand deposit. Site inspection showed a distinct toe bulge at the base of the slope (Figure 4).

There being no flat land at the base of the slope to serve as a working platform, the alternative of construction of a gravity berm from a working platform was eliminated from consideration. Analysis showed that the site could be stabilized using the soil nail stabilization technique (Gassler, Gudehus, 1983). As the installation of the soil nail reinforcement was to be effected from the face of the slope, construction would result in minimal impact to rail operations. Design showed that installation of a set of 9 m long soil nails on a 1.5 m grid would satisfy factor of safety considerations. Restraint of the slope face to the soil nails was provided by geogrid reinforcement laid on the slope face and connected to the soil nails through a system of steel straps. Following completion of construction, movement at track level was arrested after a period of a few months following installation, after the restraint system had been tensioned by the then ongoing ground movement.

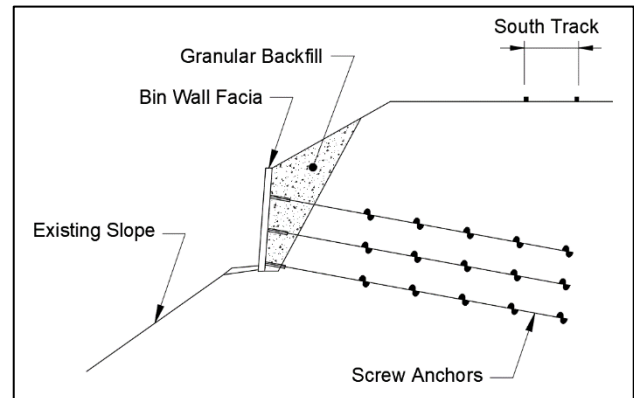
Figure 5. Cross section of bin wall and soil anchor assembly

The site location is situated in an area in which the south track had been constructed at the top of the prior slope and supported by an approximately 3 m high gravity retaining wall consisting of a set of concrete blocks topped by rail ties. The concrete block retaining wall was experiencing distress such that further deterioration would eventually threaten support to the south rail track. No track movement had been experienced however. The slope below the toe of the existing retaining wall dips to the south and lies at an inclination of approximately 35° to the horizontal; it is about 40 m high. A visual examination of the slope showed no evidence of distress, nor of a toe bulge from below the retaining wall to the toe of slope. On this basis, it appeared that the natural soil slope was stable. The limit of the right-of-way lies about 12 m outside (down slope) from the slope crest, and in the upper portion of the slope. Analysis of the global stability of the natural slope using borehole data and laboratory test results showed that the margin of stability was positive but not sufficient as per today's standard. Analysis of the stability of the upper slope showed that a wall fascia restrained by a suitable array of screw anchors drilled into the slope below the rail lines could support the upper slope and the rail tracks, and improve global slope stability by about 15%. The design utilized a "Bin Wall" fascia (Lowry, 2010) to restrain the ground to the previous slope geometry.

Work to construct the replacement retaining wall and restraining screw anchors was effected from a 4 m wide platform located on the slope crest on the south side of the south track, without interference to train movements. The approximately 20 m long retaining wall system has effectively eliminated settlement on the nearby south rail track. Access to the site was available from the north side of the north track, across a temporary crossing. Equipment to install screw anchors and the wall fascia stood on the flat platform between the south track and the crest of the slope.

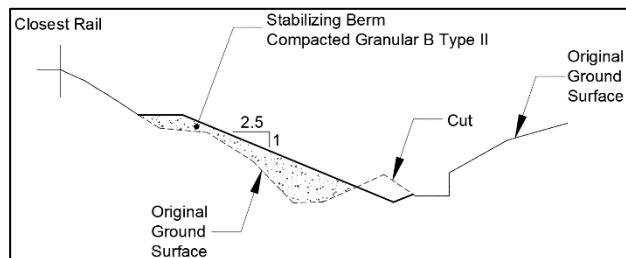
Figure 6. Cross section of gravity berm

A drainage ditch is located on the north side of the north track at the study site. The invert of the drainage ditch was situated approximately 6 m below rail track level. For most of the year, the ditch is dry, however, run off at the time of the spring freshet had caused both side cutting and down cutting in the ditch which has compromised the safety of the rail tracks which were supported by the side slope. Although abnormal settlement was not being experienced at track level, the margin of stability in the slope was adjudged inadequate for unrestricted rail operations. The width of right-of-way in the affected length of track was such that the alignment of the drainage ditch could be sufficiently moved to the north to allow a conventional unreinforced gravity berm (Skempton, Hutchinson 1969) to be constructed to support the track and improve its factors of safety. The eroded flanking slope was adjudged unsuitable to setup equipment for installation of soil nails. Temporary storage space was available.

Access for materials and equipment could be made at the eastern limit of the affected area such that the materials could be taken to the site across a temporary crossing without a need to travel along the tracks.

The north ditch being considered fish habitat by the local Conservation Authority, environmental measures were implemented as part of the stabilization measures, which contributed to delay the commencement of the stabilizing work for a period of about two years.
