Case Study - Challenges faced in Port Lands Flood Protection and Enabling Infrastructure (PLFPEI) Toronto Project

Charbel Abi-Nahed, Hannah Chessell, David Drago, Jim Hansen¹, Ali Nasseri-Moghadam
Geosyntec Consultants International Inc., Waterloo, Ontario, Canada
¹*Geosyntec Consultants International Inc., Oak Brook, Illinois, USA*

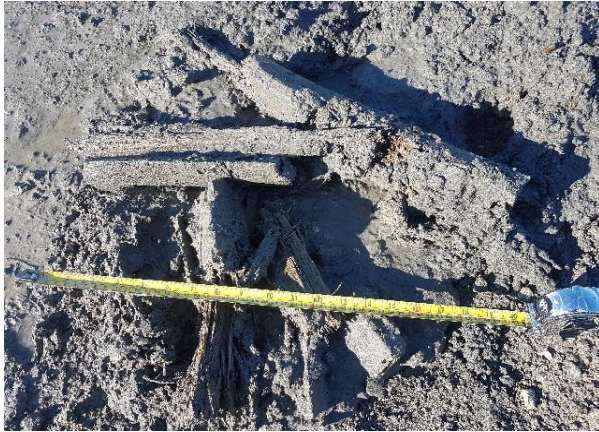
Additionally, the subsurface conditions from previous industrial site use lead to several liners getting stuck. Wood obstructions were the primary obstruction type that hindered liner advancement as seen in Figure 6.

Figure 6. Wood obstruction

When a liner got stuck due to an obstruction, the contractor would spend few hours trying to push the liner further down. However, if no advancement is made, the hole would be poured with 8 Megapascal (MPa) concrete and then re-drilled at a later stage.

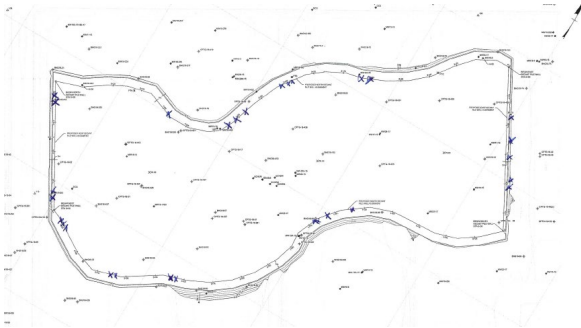
Figure 7 shows the location of those obstructions throughout the work perimeter.

Figure 7. Wood obstruction locations

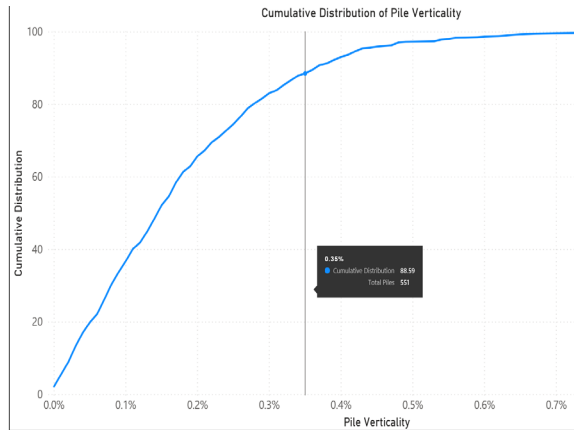
Through the IMS, it was determined that nearly 90% of the piles met the 0.35% verticality target as shown in Figure 10.

Figure 10. Cumulative Distribution of Pile Verticality

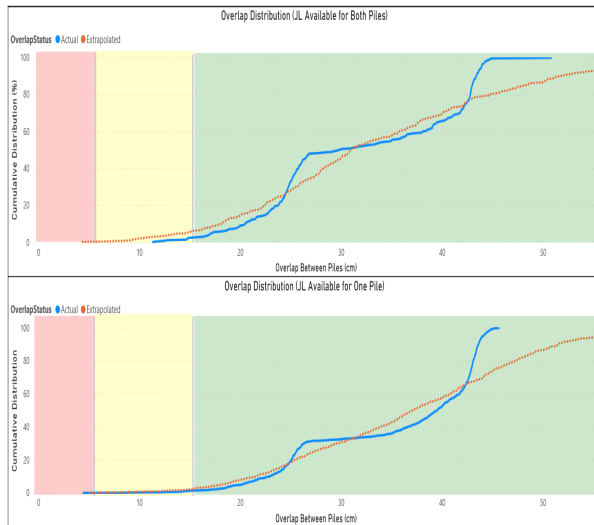
For piles with greater than 0.35% tilt, the pile toe overlap was reviewed. 99.87 % of the piles exceeded the 5-cm target overlap requirement for pile toe caps as shown in Figure 11.

Figure 11. Overlap Distribution

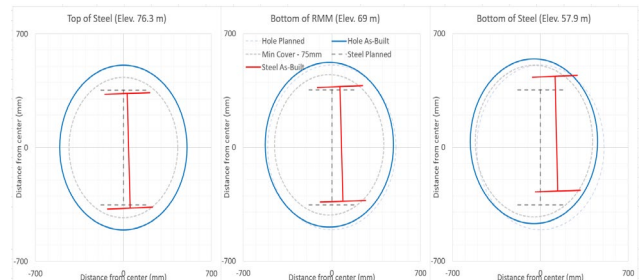
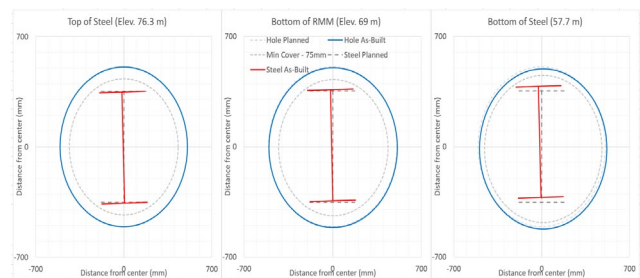
Figure 13.a. Reinforcement Verticality without centralizers

Figure 13.b. Reinforcement Verticality with centralizers

At 18 m depth, the piles are projected to protrude through the pile footprint without the use of centralizers, whereas when the centralizers were added on the steel beam, a better control was observed.

Figures 13-a and 13-b show the increased efficiency of the use of centralizers on the beam's verticality.

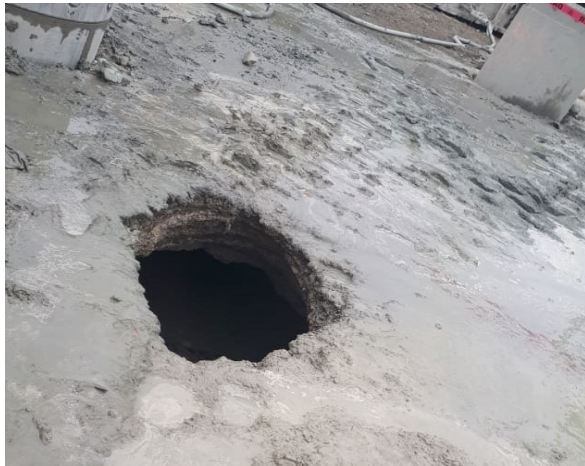
The voiding could be attributed to the loose fill and sand material shown by the low SPT N60 values and the shallow groundwater level as discussed in section 1.2. It may also

be caused by poor ground preparations prior to mobilization.

The first void occurred in July 2019 on the west wall of the site. Multiple voids appeared on surface through the engineered work platform of that same wall throughout the summer of 2019 which lead to a complete production shut down on the west wall. Figure 14 shows the void at the South-West corner which occurred in September 2019 and caused the West wall work to shut down while an engineering solution was implemented.

Figure 14. South-West corner void

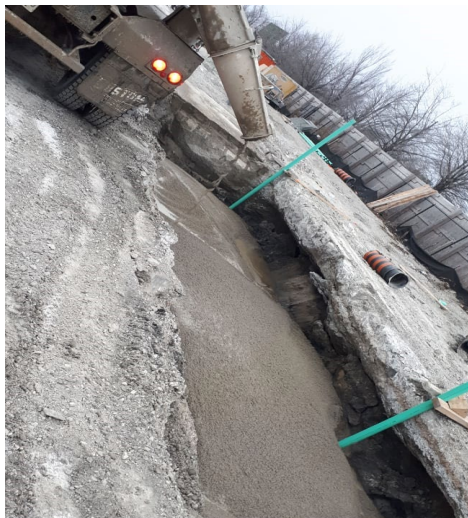
Figure 15. Concrete pad

The excessive voiding on the west wall was remediated by excavating a concrete pad through the drilling platform in January 2020 as shown in Figure 15. The pad had an approximate depth of 2 m and width of 2.5 m.

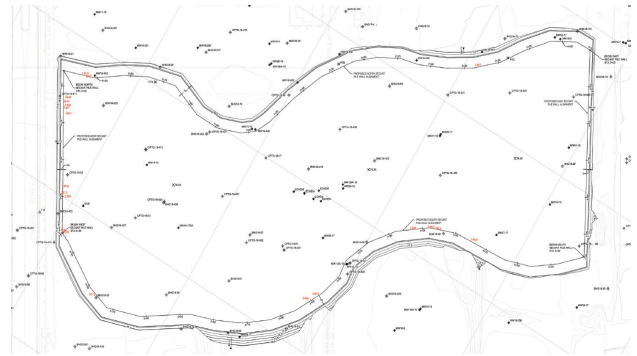
The voids are highlighted in their respective locations on figure 16.

Figure 16. Void Propagation throughout work area

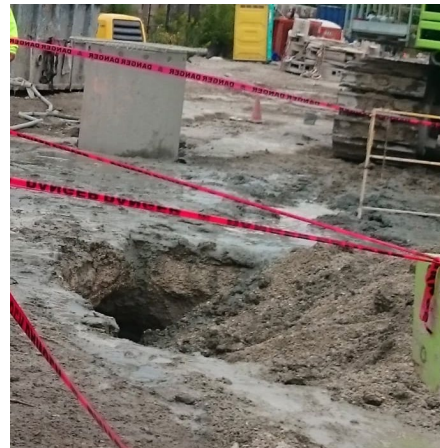
The void remediation measures taken on-Site consisted of immediately vacating the area following the discovery of a surface void due to the significant safety hazard posed. An investigation was then conducted by excavating around the void (using a mini-excavator) to expose its extent as shown in Figure 17.

Figure 17. Void Investigation

A remedial solution was then proposed according to the extent of the void. Often, the void and the excavated area were filled with 5 MPa concrete. Work was typically resumed 48 hours following the remedial backfill activities.
