Tailings dike seepage mitigation through adaptive tailings deposition sequencing

Marion Habersetzer & Yves Boulianne
Golder Associés Ltée, Montréal, Québec, Canada

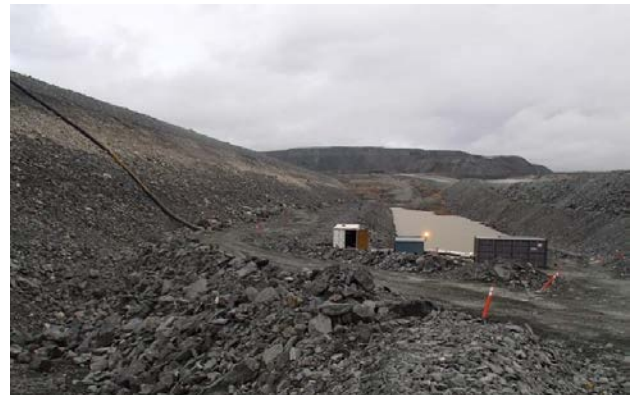
The dike became operational in 2014 when the tailings started being hydraulically deposited in the TSF. From that moment, water was observed ponding at the downstream toe of the dike, as shown in Figure 1 below, indicating seepage through or below the structure. Chemical signature of the seepage water indicated that it originated primarily from the attenuation pond within the tailings, although no tailings were present in the water, which remained clear to slightly turbid. Observations of groundwater flow during construction suggest that groundwater contributes to a fraction of the seepage. A pumping station was installed in the downstream pond and seepage flow was monitored using a flowmeter. The seepage flow measurements showed that it largely exceeded the design seepage. It reached 800 m³/h in August 2015. No water was observed reporting to the nearby open pit.

Figure 1: Picture of the downstream pond at the toe of the dike formed by seepage and pumping station

- Maintain the downstream pond level at El. 115 m by adjusting pumping to control hydraulic gradients exiting at the downstream toe;
- Monitor frequently the seepage rate using the pumping station flowmeter;
- Modify the tailings deposition sequence to promote not only the development of tailings beaches against the structure, but also a tailings blanket over the TSF foundation, targeting zones of suspected high permeability features. It was expected that the fine slurry would fill granular till channels and fractures in the bedrock, reducing their hydraulic conductivity;
- Install additional instrumentation in the preferential seepage area.

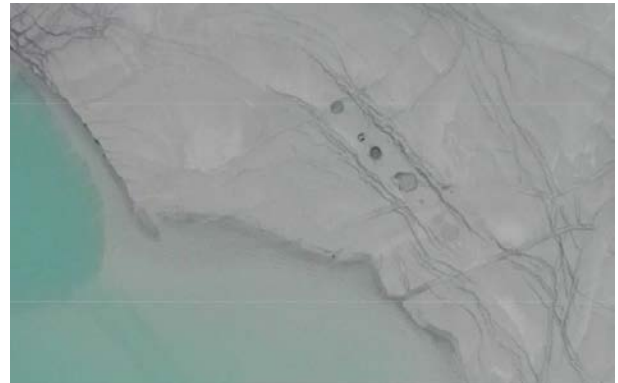
Figure 4: Localized tension cracks and circular depression features in the tailings surface, indicating entry points into the underlying foundation

A baseline deposition sequence was established to optimize the TSF storage capacity. Then, through monthly strategic sequence updates, the active deposition point was switched at selected times based on suspected entry points and observed seepage features such as depressions in tailings. These depressions, an example of which is depicted in Figure 4 below, indicate a loss of water through the fractured bedrock and a priority zone for the tailings blanket development.
