HAZARD ASSESSMENT OF DEBRIS FLOWS INITIATED BY BREACH OF SMALL EARTH DAMS IN BRITISH COLUMBIA

S.A. Mehdizadeh
Englobe, Toronto, ON, Canada
D.D. Tannant
University of British Columbia, Kelowna, BC, Canada
F. Saadat
DST Consulting Engineers Inc., Toronto, ON, Canada

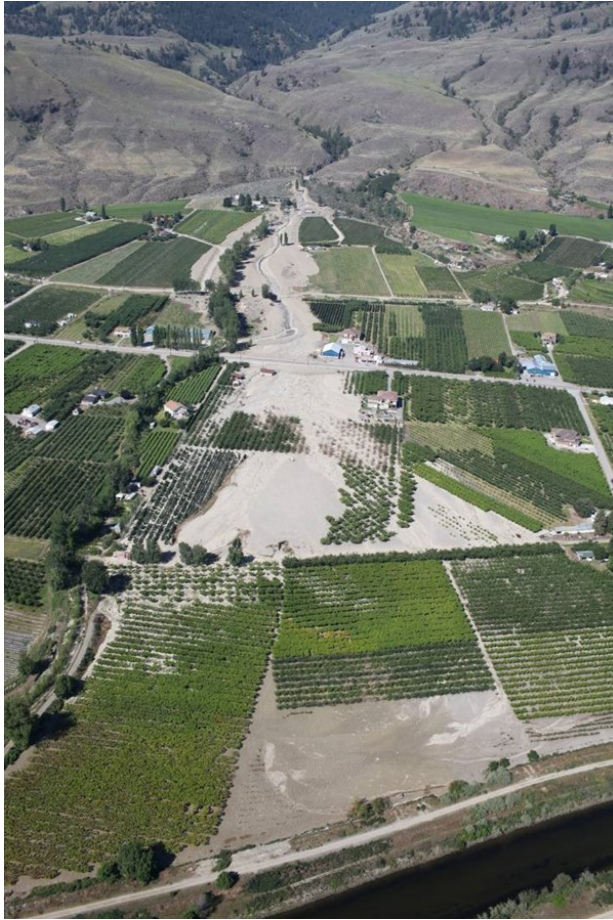
Figure 2. Debris flow deposit on Testalinden Creek fan

Once the debris flow reached the lower gradient fan, deposition began forming a long asymmetrical triangle of sediment that buried the original channel and created a new one that is approximately 1.4 km long (Figure 2). The overall area on the fan affected was approximately 23.6 ha. According to the test pit results, and lidar surveys conducted on the fan, the estimated volume of the debris and sediment is 240,000 to 260,000 m³ (Higman et al. 2011).

The debris flow destroyed or badly damaged five homes and caused significant damage to crops and farm equipment, covered 200 m of Highway 97, and blocked several secondary roads. In response to this failure, the BC government revised its dam safety program and legislation and increased emphasis on dam safety (Tannant 2015). The BC Deputy Solicitor General made a number of dam safety recommendations, and BC dam safety officers were busy for two years implementing these recommendations. Some of these actions were performing a rapid dam assessment, revising the BC Dam Safety Regulation, updating of the dam registry, creating greater access to information by dam owners, providing local government and the public with tools such as dam locations and basic information in iMap and Google Earth (BC Dam Safety Program 2011; 2012).

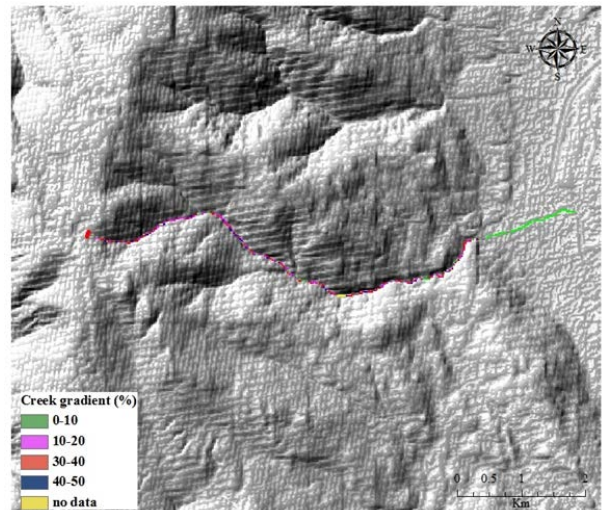
Figure 3. Testalinden Creek DEM and gradient

Testalinden Creek is a third-order stream channel with a total length of 8.8 km. The creek starts at Testalinden Lake at an approximate elevation of 1810 m near the top of the watershed. The uppermost elevations of the Testalinden Creek watershed are at an approximate elevation of 1850 m. Testalinden Creek flows eastward into the Okanagan River at an approximation elevation of 285 m. The drainage area of Testalinden Creek is 12.65 km². The creek gradient is one of the important factors needed to assess debris flow initiation using debris flow initiation thresholds. The slope of the channel was derived from a DEM of the studied area. The DEM grid cell size is 20 m, and cells are projected on a NAD83 UTM coordinate system. Two methods were used to determine the slope of the channel using ArcGIS software. The channel gradient was calculated by spatial and raster analysis, or a simple profile was created. Figure 3 presents the creek gradient.

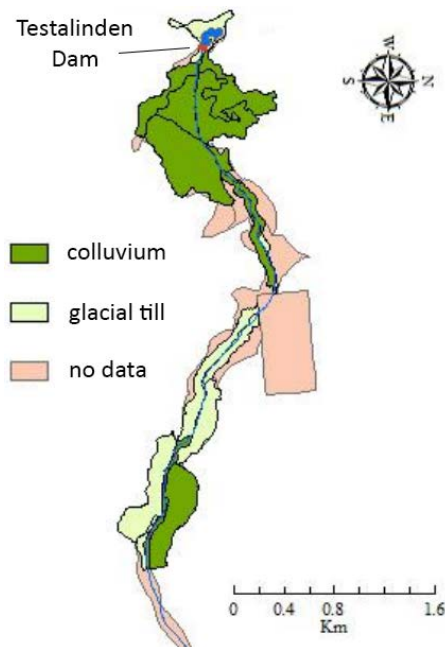
Figure 4. Surficial geology in the upper reaches of Testalinden Creek

Figure 4 shows that a length of 1526 m along the creek is located in glacial till, 546 m of the creek has colluvium in the creek bed, and there is no information on the sediment type available for the lower reaches of the creek.

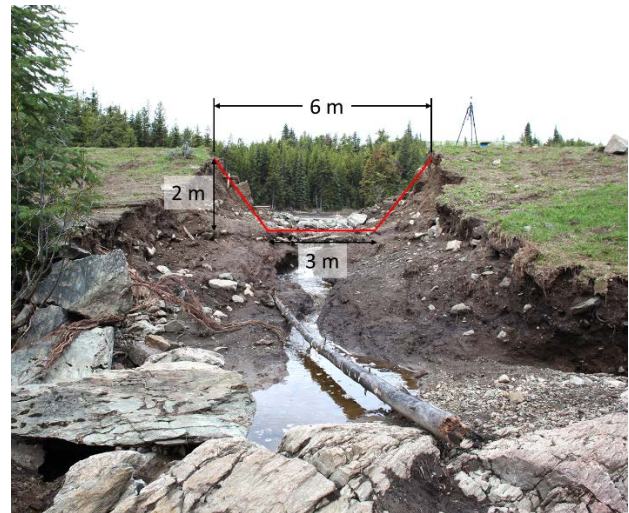
Figure 5. Testalinden Dam breach

On June 11, 2010, a hiker noticed water flowing across the road that ran along the crest of the dam (Morhart 2010). The report of his observations was not passed along to the appropriate authorities until after the breach occurred at approximately 2:15 pm on June 13, 2010. The breach in the dam released approximately 20,000 m³ of water. The released water descended the creek to the Okanagan valley entraining materials from the creek, initiating a large debris flow, and growing to more than 240,000 m³ in volume by the time it reached the alluvial fan.

The technical reasons for the dam failure were investigated, and it is likely that a combination of late-season snowmelt and rainfall, which overtopped the

roadway/dam, and an ineffective culvert were contributing factors (Morhart 2010).

Figure 5 shows a photograph of the breach, along with a simplified cross-section of the breach. Based on the cross-section geometry, the height of water above the bottom of the breach at the time of dam failure was 2.2 m, and the volume of water in the reservoir was estimated to be slightly more than 20,000 m³. The breach width was approximately 6 m, as seen in Figure 5.

The peak outflow from the Testalinden dam breach was estimated by applying various existing empirical dam breach equations. These equations predict a peak outflow ranging from 1 to 300 m³/s. Thus there is considerable uncertainty in the prediction of peak outflow using these regression equations. Wahl (2004, 2010) did an uncertainty analysis of various equations used to predict peak outflow for 108 case studies and suggested that Froehlich's (1995) method has the least error. Froehlich's equation predicts a peak breach outflow of 30 m³/s for the Testalinden Dam, which seems to be a reasonable estimate.

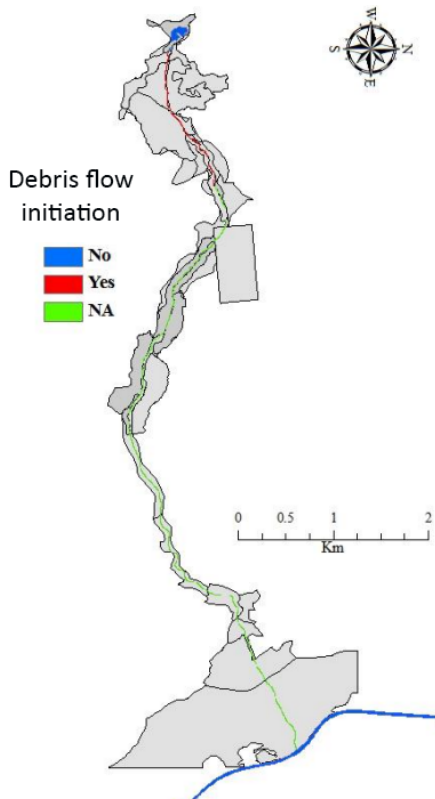
Figure 6. Sections of Testalinden Creek where debris flow initiation is predicted to occur

Two methods were used to investigate debris flow initiation in Testalinden Creek: Takahashi (2007) and Berti and Simoni (2003). In Takahashi (2007), debris flows are predicted to occur in a gully bed steeper than a critical gradient and when surface water flow exceeds a discharge flow rate that can wash out the creek bedload. Berti and Simoni (2003) stated that when the Factor of Safety is less than unity, a debris flow can initiate. More information about the parameters and thresholds used in these methods can be found in the referred references. Figure 6 shows a map of the reaches along the Testalinden Creek where debris flows are predicted to occur when applying the Takahashi (2007) and Berti Simoni (2003) thresholds in an ArcGIS raster analysis.

The estimated discharge from the Testalinden Dam was predicted to be capable of triggered debris flows in reaches with a slope greater than 10° . Since most of the creek is confined to a V-shaped valley with a slope greater than 10° , a debris flow was easily able to initiate and grow as the water released by the breach in the dam travelled down toward the valley bottom.

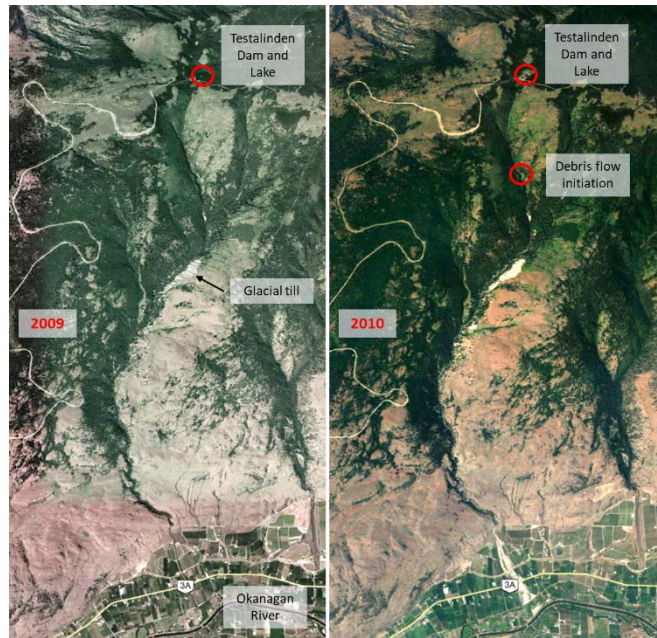
Figure 7. Probable debris flow initiation location

Figure 7 shows Google Earth aerial photographs captured before and after the dam failure. Evidence of the debris flow is visible. The highlighted circle indicates a point along the channel where evidence of debris flow scour of the channel becomes obvious. This location is where more substantial quantities of sediment and debris were expected to be present in the channel. At this point, evidence of scouring and vegetation removal starts and continues down the channel all the way to the fan. This spot is located 2 km downstream from the dam. The starting point matches a reach where debris flow is predicted to initiate in Figure 6.
