## Design, Construction and Long-Term Performance of a Major Highway Embankment Reconstructed using Tire Derived Aggregate (TDA)

Bernie Mills  
*Stantec Consulting Ltd., Calgary, Alberta, Canada*

Jared McGinn  
*New Brunswick Department of Transportation and Infrastructure, Fredericton, New Brunswick, Canada*

Hany El Naggar  
*Dalhousie University, Halifax, Nova Scotia, Canada*

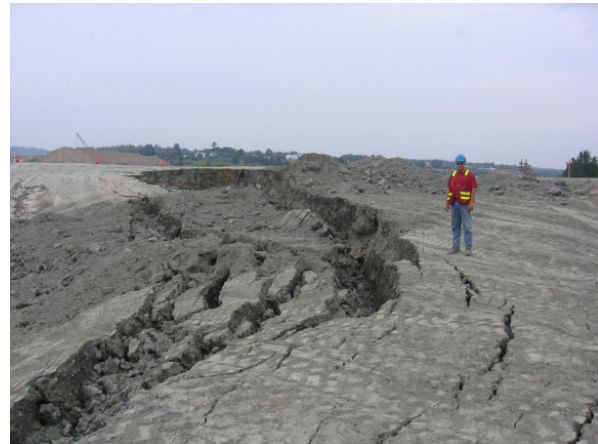
The embankment failure occurred in July 2006 during construction of a four-lane divided highway leading to the Canada/USA border crossing in St Stephen, New Brunswick, Canada. The highway embankment was approximately 12.3 metres in height when it failed, just short of the design height of 14 metres.

To assess the cause of the failure and to develop possible repair strategies, a forensic geotechnical investigation was carried out consisting of traditional auger boreholes, cone penetration testing (CPT) and installation of geotechnical instrumentation. The results of the geotechnical investigation concluded that the failure was caused by the rapid rate of construction and the overall intensity of the embankment loading on the low strength foundation soils consisting of 15 metres of soft marine clay. The failure was described as a relatively deep-seated circular slip failure with some lateral spreading. The failure encompassed an area of approximately 130 metres in the longitudinal profile by 60 metres in cross-section. Figure 1 shows the failure from the top surface of the embankment looking west. Figure 2 shows the failed embankment cross-section through the centre of the failure including the modeled failure circle through the marine clay layer.

Figure 1. Embankment Failure Condition, July 2006

After reviewing various repair options, reconstruction of the embankment using TDA lightweight fill combined with stage construction and prefabricated vertical drains (PVDs) was selected. The TDA option was selected by NBDOT because it was estimated that it would save the province 30 percent of the total cost as compared to the next feasible option (Stone Columns).

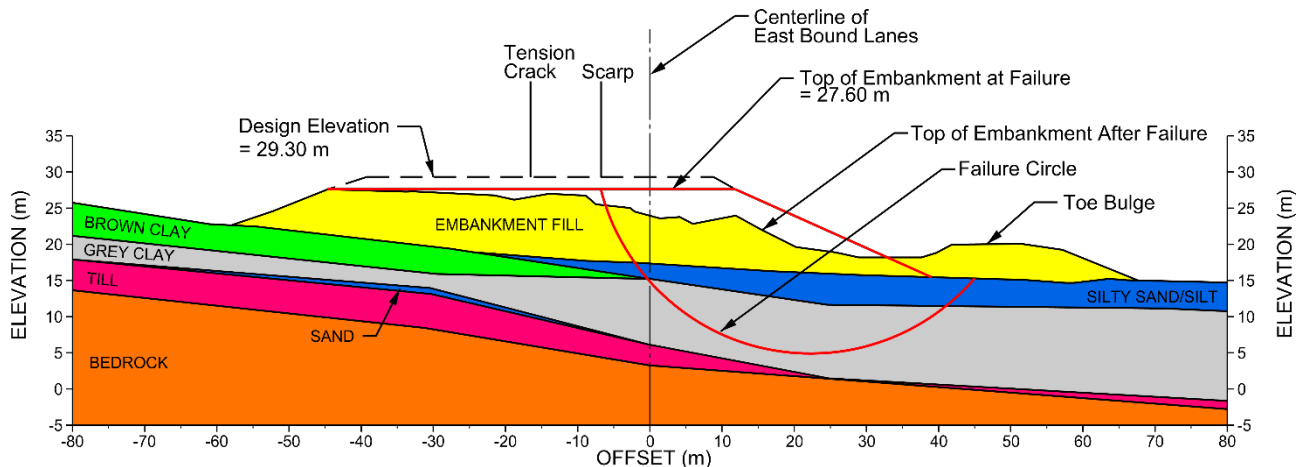
Figure 2. Embankment Cross Section Through Center of Original Failure

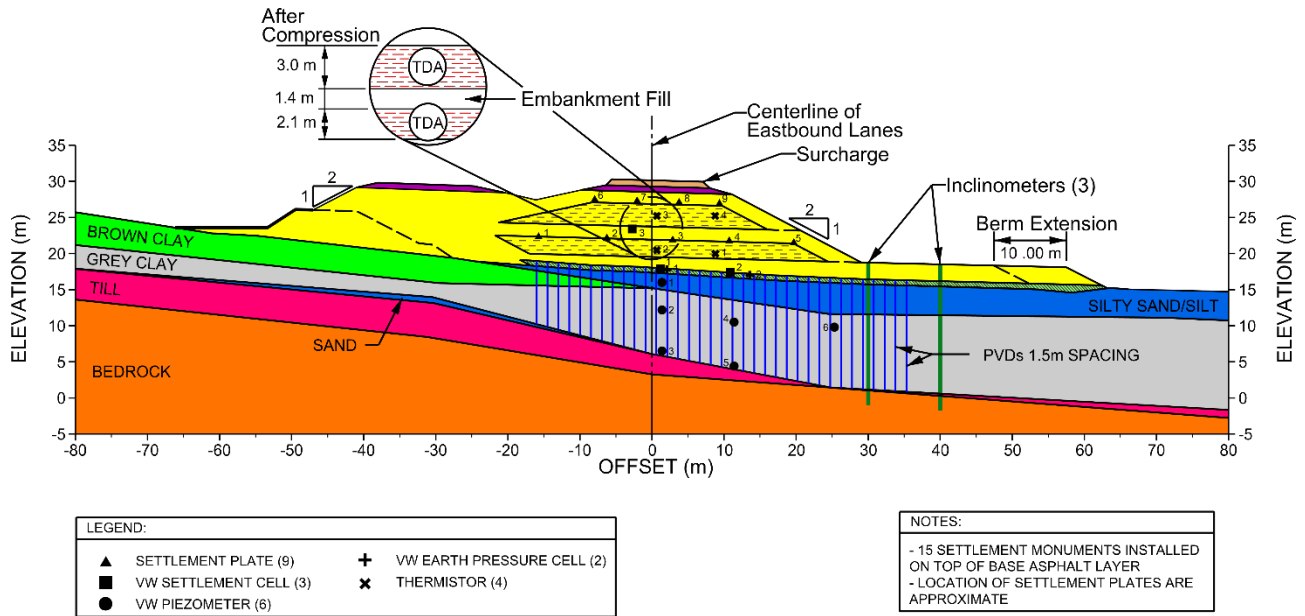
Figure 3. As-Built Cross Section Through Centre of Original Failure Showing Instrumentation

- The design considered an observational approach using the geotechnical instrumentation as shown on Figure 3.

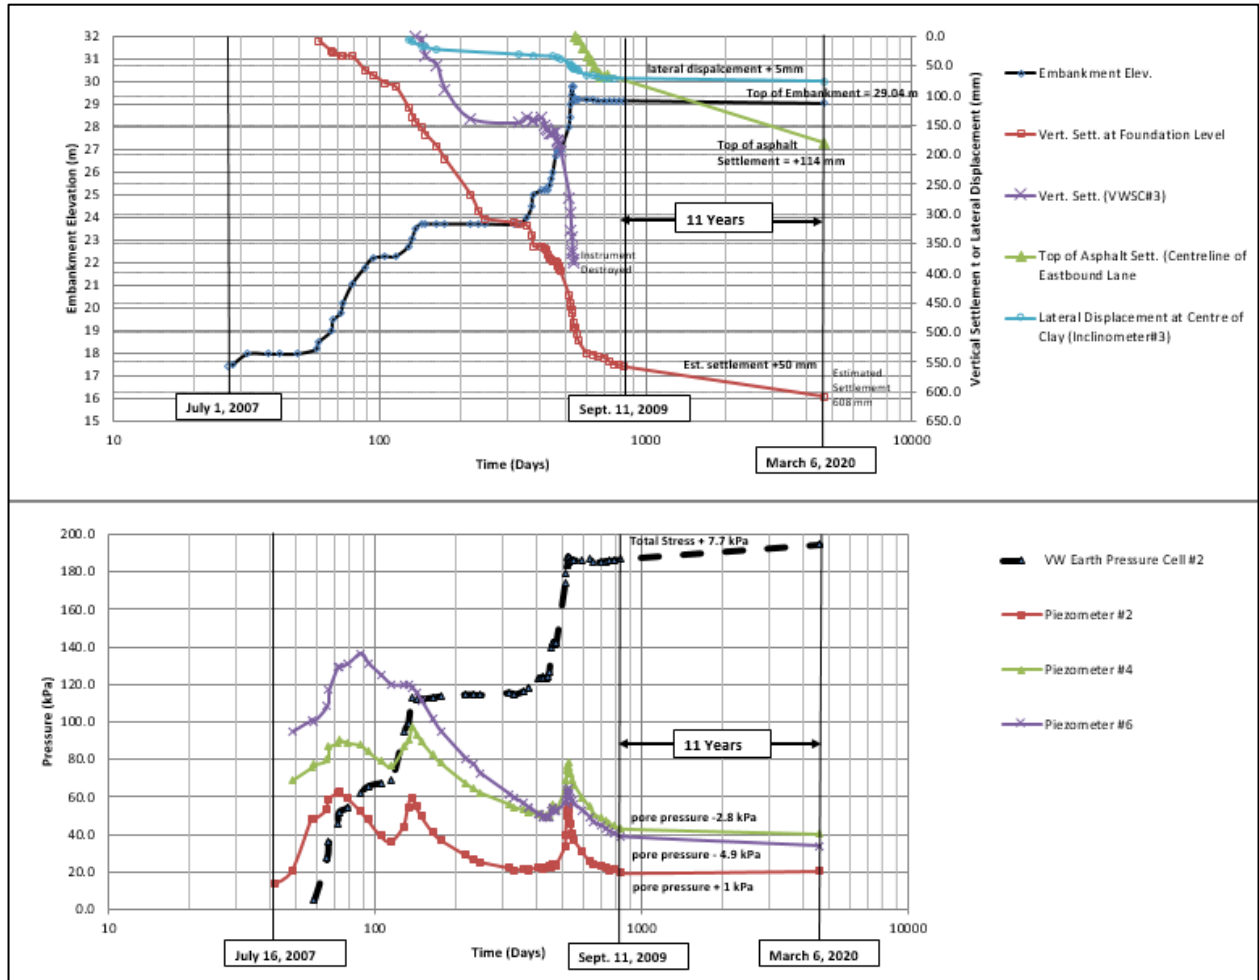
Figure 6. Instrumentation Readings

Figure 6 shows the instrumentation readings and TDA embankment and foundation performance over a 27-month period from July 1, 2007 to Sept 11, 2009. It shows the rate of construction and the resulting total stress increase at the foundation level, pore pressure response in the underlying clay, vertical settlement at the foundation level and within the embankment, and lateral displacement at the centre of the grey marine clay layer.

The average total stress increase from the embankment loading was measured to be 186 kPa resulting in a total settlement response of 550 mm over the 25-month construction period at the foundation level. The pore pressure in the clay responded to an increase in total stress from the embankment loading and decreased rapidly for the first 50 days after fill placement ceased. The vertical settlement response of the clay was almost immediate upon loading and continued after loading ceased for an additional 70 to 100 days after each loading stage. Top of asphalt settlement results indicated that the asphalt surface settled approximately 70 mm over a period of five months, and then became negligible.

As shown on Figure 6, the March 6, 2020 instrumentation data compared to the readings on Sept. 11, 2009 show the following:

- Over the past eleven years, the pore pressures in the marine clay layer below the TDA embankment have decreased as much as 5 kPa.

- Since the pore pressures and embankment have returned to a long-term drained condition, the total stress at the foundation level has correspondingly increased by approximately 8 kPa from 186 kPa to 194 kPa.
- The total lateral displacement measured in the centre of the marine clay layer was 76 mm on March 6, 2020, an increase in 5 mm since 2009. This lateral displacement is as a result of consolidation settlement in the foundation clay.
- The VW settlement cell data retrieved on March 6, 2020 are considered erroneous and unreliable, so the data was not included on Figure 6. The likely sources of error are related to the lack of liquid maintenance of the VW settlement cells over the past 12 years.
- Settlement of the embankment at the foundation level has been estimated based on the 2020 top of asphalt survey and the 2020 lateral

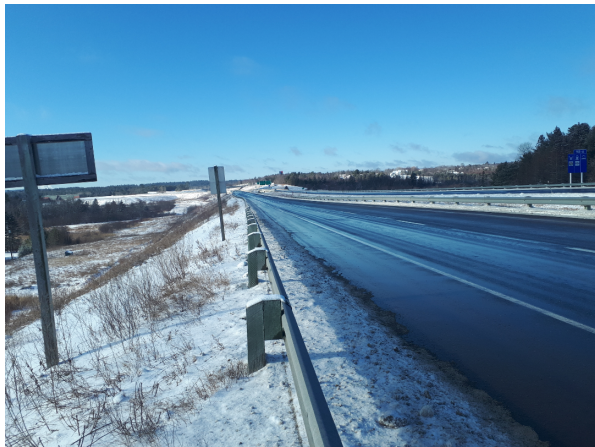
The owner and designers returned to the site in January 2020 (Figure 7) and again in March 2020 to review the condition of the TDA embankment. There were no signs of embankment instability, cracks, slumps or erosional features and the TDA embankment appears to be performing as designed.

Figure 7. TDA Embankment, Jan 2020

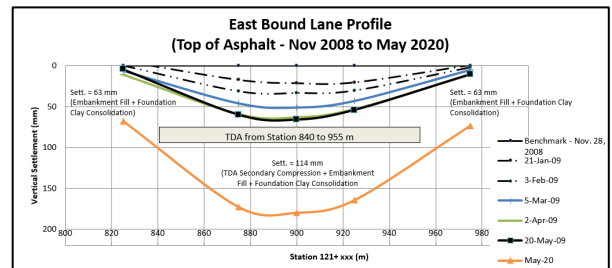
The survey results show that the top of asphalt above the TDA embankment settled between 110 mm and 114 mm over an eleven-year period. It is estimated that 50 mm of the 114 mm settlement is from TDA secondary compression, plus 50 mm from consolidation settlement of the foundation clay, and the remaining 10 mm to 14 mm is from consolidation settlement of the embankment fill.

The settlement of the top of asphalt outside of the TDA embankment settled 63 mm over the same eleven-year period. It is estimated that 50 mm of the 63 mm is from consolidation settlement of the foundation clay, and the remaining 13 mm is from the embankment fill consolidation settlement.

Figure 8. Settlement of Asphalt Surface over Time

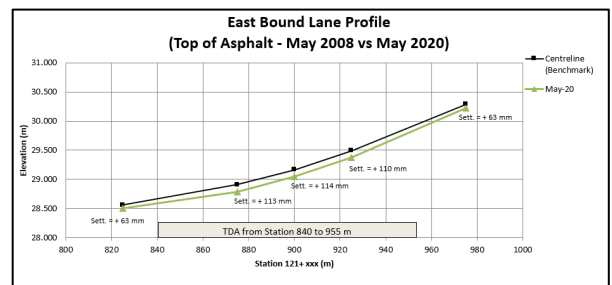
The top surface of the asphalt along the centreline of the east bound lane was surveyed in May 2020 and compared to the 2008 and 2009 survey results. Figure 8 shows the vertical settlement of the top surface of the asphalt over 2008 and 2009 compared to the May 2020 survey results. Figure 9 shows the east bound lane profile in May 2009 compared to May 2020.

Figure 9: East Bound Lane Profile
