A case study of reinforced soil slopes in Ontario

Laifa Cao & Scott Peaker
WSP Canada Inc., Toronto, Ontario, Canada

This paper presents a case study of reinforced soil slopes (RSS) along Bathurst Street in the Region of York, Ontario. Six RSSs were designed to be up to 10 m in height and reinforced with geogrids at vertical spacings of 0.6 m for the roadway embankments over three culverts. The slope angle was 70° and slope face units consisted of vegetated geocells. Two years after the RSS construction, the face units of one RSS collapsed after a significant rain event. Field investigation and global stability analysis were carried out. It was found that the possible failure mechanisms of the RSS were the infiltration rate of surface water exceeded the drainage capacity of the RSS and the buildup of hydrostatic pressure exceeded the sliding resistance between the geocells. The failed face units were then reinstalled using the same geocells with the installation of a vertical drainage layer behind the geocells. Following the reinstallation of the face units of the RSS, ground movement monitoring was conducted for all RSSs over the culverts. Field inspection was carried out one ye

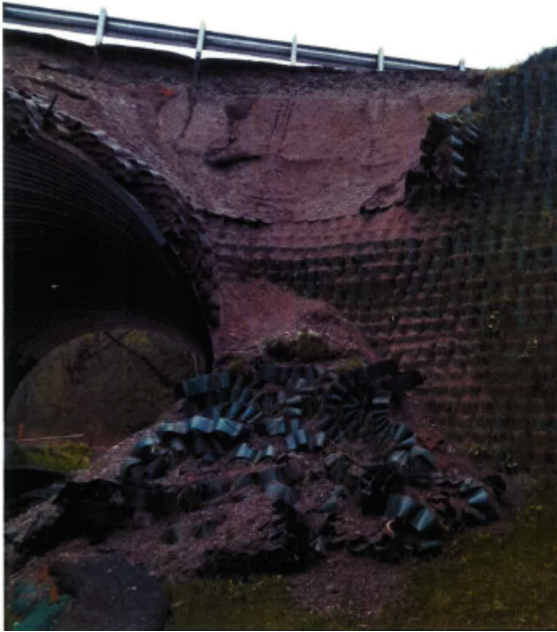
Following the period of heavy rains in late April and early May of 2017, the RSS at Culvert A failed in early May 2017. As shown in Photo 1, the failure feature was concentrated around the culvert, and that the base of the failure surface was at a depth of approximately 6 m from the top of the embankment. The photo also shows that the scarp of the slope was at the inner edge of the shoulder area. The pavement structure of roadway was largely unaffected by the failure. However, a number of cracks were observed on the road shoulders at Culvert A as well as at Culverts B and C built using the same method and material as Culvert A. Movement of about 100 mm was observed on the top of RSS at Culvert 3.

Photo 1. Failure of reinforced soil slope at Culvert A

- 1) Excessive amounts of surface water runoff from the road spilt over the top of the RSS;
- 2) The infiltration rate of surface water exceeded the drainage capacity of the RSS;
- 3) The exceedance caused buildup of hydrostatic pressure on the back of the face units;
- 4) Top-down buildup of the hydrostatic pressure gradually exceeded the sliding resistance between the face units; and
- 5) The face units pushed the RSS to fail.

- The failure of the reinforced soil slope at this site was mainly due to the infiltration rate of surface water exceeding the drainage capacity of the RSS and weak connection between face unit and the geogrid. Installation of impermeable layer at the top of reinforced soil slope will prevent excess infiltration. The face unit should be physically connected with the geogrid reinforcement for the RSS design.
- Maintenance of face units for the reinforced soil slope is required if they are not properly vegetated.

- 1) Building of a concrete or asphalt curb and formation of a shallow swale along the line of the guard rails to prevent future spill. The curb should be high enough to contain the maximum estimated runoff.
- 2) Installation of soil nails to establish physical connection between the face units and the geogrid reinforcement in order to improve sliding resistance.

The first recommendation was accepted. The second recommendation was not accepted and replaced by movement monitoring of the RSSs using inclinometers and survey targets at the three culverts.

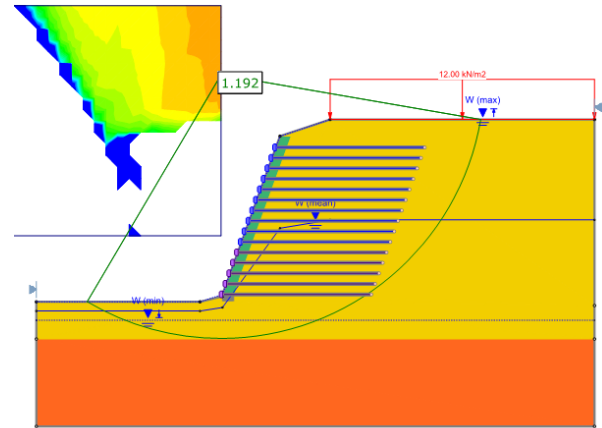
Bishop simplified method give the lowest factor of safety (FOS) for the global analysis of the RSS among the different slice methods. Figure 2 shows a FOS of 1.192 when the water table rises to the middle level of RSS using Bishop simplified method. Figure 3 shows the FOS decrease from 1.5 for the water table at 1 m below the RSS to 0.72 for the water table at the top of the RSS. When the 70% of the RSS is below the water table, the RSS will be unstable with a FOS less than 1. This means the global stability of the RSS is significantly affected by the water table.

Figure 2. Global stability of RSS with middle water level

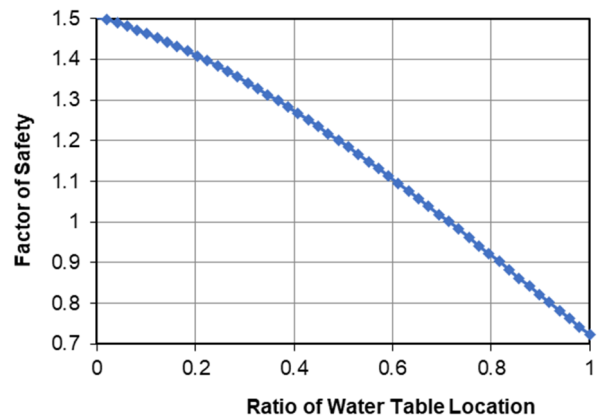
Figure 3. Variation of factor of safety with ratio of water table location (0 for lowest water table and 1 for highest water table)

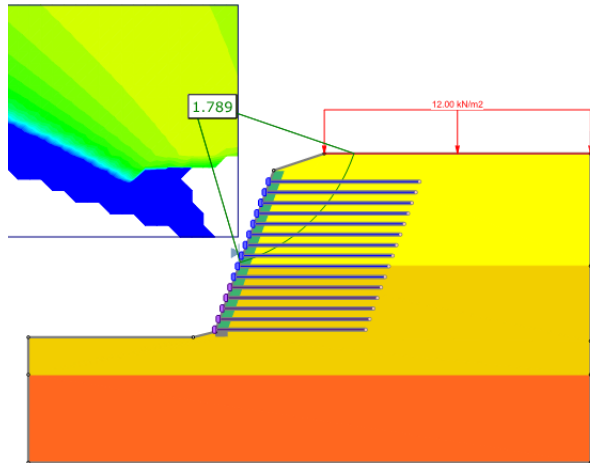
The localized analysis of the slope in dry conditions produced the minimum FOS of 1.789 as shown in Figure 4 using Bishop simplified method. The other two methods gave the FOS of 1.778 to 1.779. The value of FOS is affected by the variation of geotextile strength. If the geogrid tensile strength reduces to 14 kN/m, half of the long-term design strength, the FOS reduces to 1.31. If the geogrids are installed at a vertical spacing of 1.2 m, the FOS reduces to 1.18. These indicate that the RSS failure was unlikely due to the reduction of geogrid strength with time or less installation of geogrid layers.

Figure 4. Localized stability of RSS in dry conditions

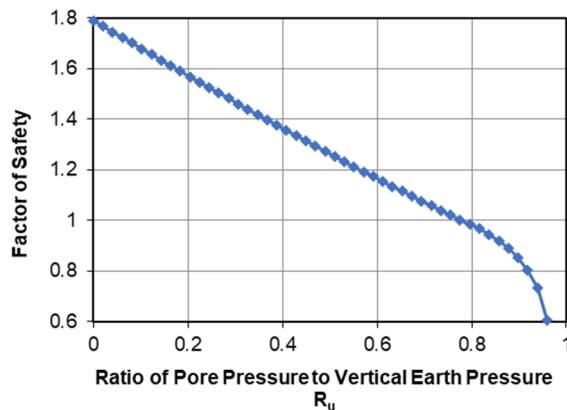
Figure 5. Variation of factor of safety with pore water pressure

The pore water condition at the top section of RSS can be modelled using a parameter, R_u defined as ratio of pore water pressure to the vertical earth pressure. If R_u is equal to 0, the soil is dry with zero pore water pressure. When R_u is greater than 0.5, the soil becomes fully saturated. Figure 5 shows FOS decrease from 1.79 to 1 when pore water pressure increases from 0 to 0.776 of the vertical earth pressure. This means that pore water pressure building

from the top, e.g. by ponding of water at the top of relatively low permeable layer, will lead the local failure of the RSS.

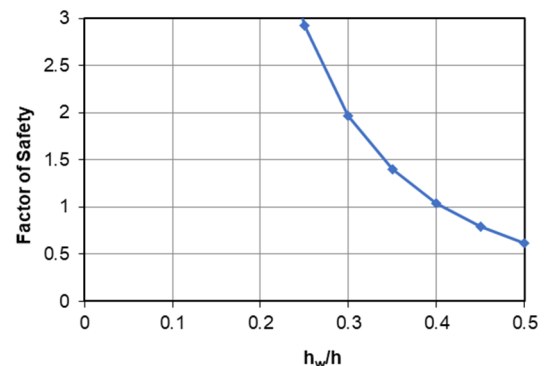
For a 6 m high stack of facing units, the factor of safety against sliding for various h_w/h is presented in Figure 6. The 6 m high facing will become unstable if there is a buildup of 2.4 m of hydrostatic pressure behind the wall.

Figure 6. Variation of factor of safety with water head

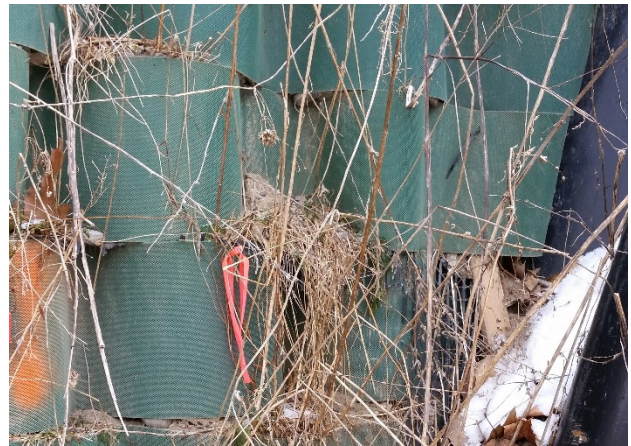
Photo 2. Local soil erosion/cell movement of west RSS at Culvert B

Based on the review of monitoring data measured in survey targets, it was considered that the majority of face units/cells of the RSS walls at Culverts B and C were stable with insignificant lateral movements. Significantly lateral movements were only observed locally, probably due to the local erosion of soil of the face units/cells as well as the consolidation of the fill material inside the face units/cells.
