Effect of spatial variability of foliation orientation on mining slope design

Joseph Kabuya Mukendi, Richard Simon

Dept. of Civil, Geological and Mining Engineering – Polytechnique Montréal, Montréal, Québec, Canada

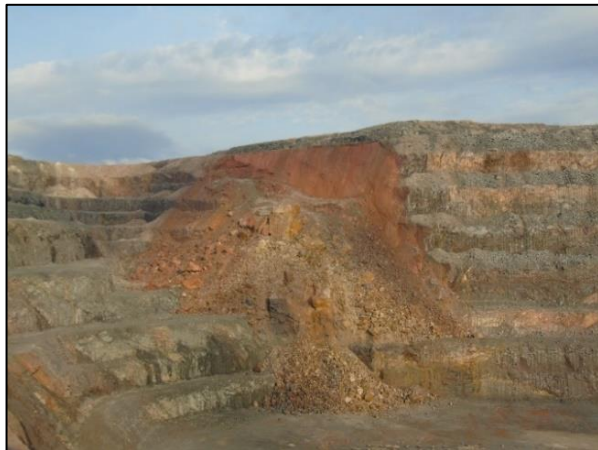
A highwall failure occurred in the southeast region of the Z pit (phase 1). The highwall instability was detected by slope stability radar and resulted in a multi-bench failure containing an estimated 3,000,000 tonnes of rock, becoming one of the most significant instability events to have occurred at the mine site (see Figure 2 for post-failure photograph). The unstable highwall was over 125 m high and 200 m wide. The overall slope angle before failure was 44°. The failure area consisted mainly of a mass of foliated QR, limited by contact with a more competent IF that was exposed on the pit wall. The radar monitoring system was thus considered to be effective for its purpose, having provided sufficient warning of the imminent collapse to allow for evacuation of personnel and equipment from the area.

Figure 2. Southeast highwall post-failure photograph

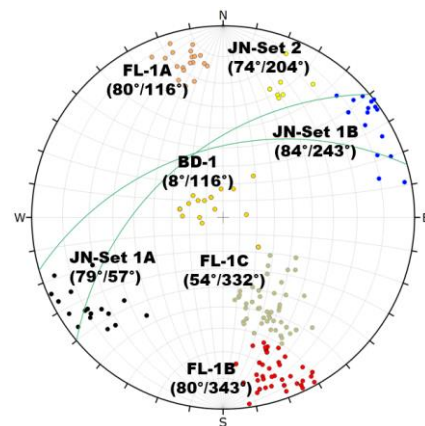
Structural interpretation indicated that the dip of discontinuities along the foliation may flatten and become progressively shallower with increasing pit depth. Separate structural regimes were defined for the upper and lower slopes in the failure area. A horizontal dividing plane was defined approximately 70 m below the crest of the pit slope, with steeply dipping foliation (FL-1B) above and more shallowly dipping foliation (FL-1C) below. This model was considered the best estimate of the structural features of the highwall failure (elevation-dependent foliation).

Figure 3. Structural interpretations of the southeast region of the Z pit (Kabuya and Henriquez, 2017)

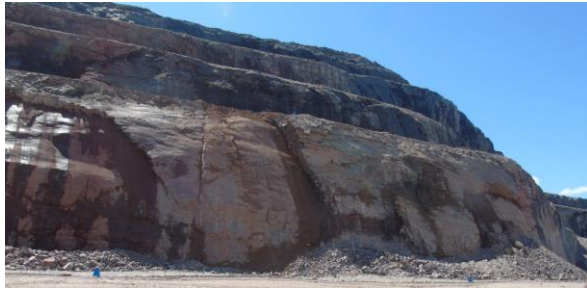
In 2019, slope failures were observed on the pushback wall in the southeast region of the Z pit. Crest losses between levels 700 and 728 occurred in the QR. It can be observed (Figure 4 and Figure 5) that failure materials accumulated at the toe of the slope and the presence of slabs on the bench face. These losses in catch-bench width seemed to follow the same plane, with variable orientation. The presence of a fault was suspected since the orientation of this plane is similar to that which caused the highwall failure located in front of the current slope (phase 1). The height of the overall slope is 84 m and is expected to reach 252 m.

Figure 4. Slope failure and slabs observed on the southeast wall (bench 700-728)

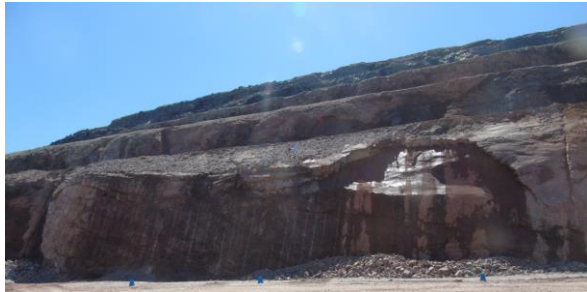
Figure 5. Slope failure and slabs observed on the southeast wall (bench 700-728)

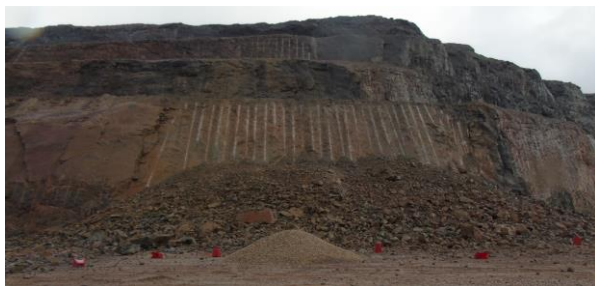
Figure 6. Bench face cleanup

The wall of the southeast region resulted in a foliation plan undercut and the slabs remained on the bench face. The slabs remaining on the bench face created a potential safety hazard that should be removed. Secondary scaling of bench faces was performed with the equipment positioned on the bench floor. Scaling from the bench above by chaining the face using a chain with attached dozer track plates was not possible due to the reduced bench width remaining. To eliminate all slabs remaining at the crest, it was decided to blast the slabs along the plan of foliation where it was possible. Figure 6 shows the bench face cleanup and the post-blast materials accumulated at the toe of the bench, which would also be cleaned up.

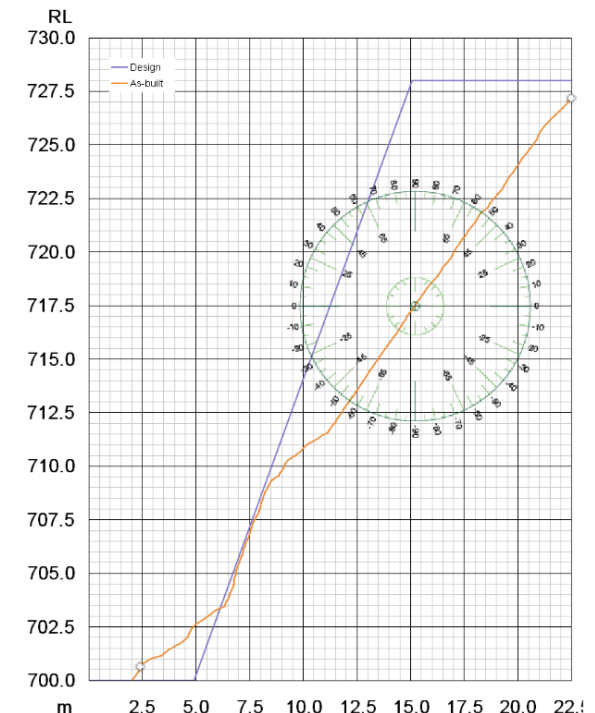
Figure 8. As-built and designed bench face (A-A)

It can be observed that the breakback is almost 8 m. The overbreak zone of the pit wall is observed from the crest to the 709.5 m level. The as-built slope face angle is 55°. Conformity to design is observed from 709.5 m to 703 m. This indicates that the presplit was made at 70°, according to the design, and undercut the foliation, causing the slope failures observed. Loose materials are observed between 703.5 and 700 m. Cleanup of loose materials along the bench toe would be required to continue mining operations.

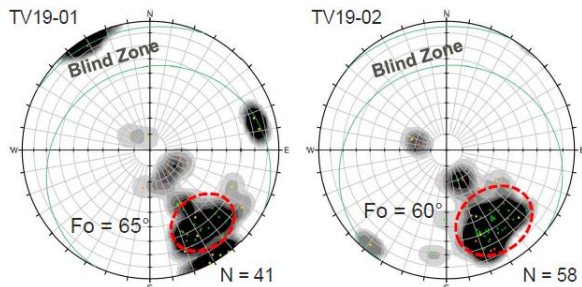
Figure 18. Stereonets of TV19-01 and TV19-02

The results of this investigation suggest that the plane on which the rupture occurred is not a fault but rather a plan of foliation associated with the bedding, which changes direction in this sector. It can be seen in the figures that it is a set of discontinuities whose orientation varies along the strike of the wall. For TV19-06 hole, the foliation dip seems subvertical although little data has been collected.

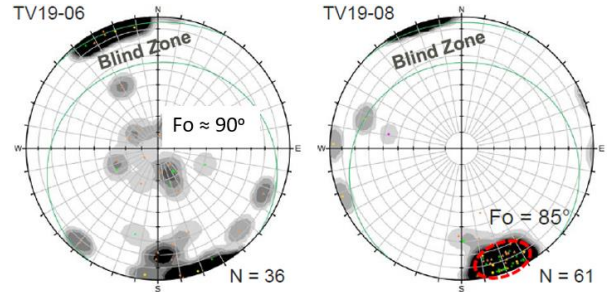
Figure 20. Stereonets of TV19-06 and TV19-08

The southeast wall is currently being developed assuming that the bedding is facing the wall. The results of these televiewer surveys suggest that the bedding is rather oriented towards the pit and that this wall should be developed as a footwall following the foliation dip. Otherwise, the results suggest that a partially open QR/IF contact, parallel to the wall, is present only at the small eastern area. This was observed only in the TV19-8 hole at 11.4 m. The wall should be monitored during mining operations in the location of this hole.

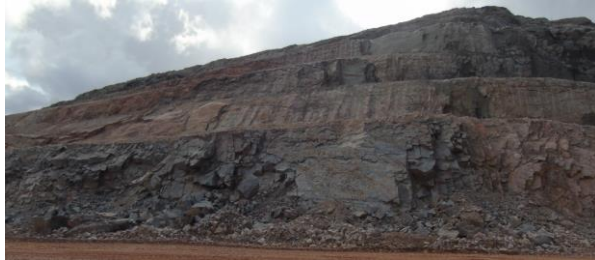
Figure 21. Free face between levels 686-700

to adjust the bench face angles based on measured foliation orientation along a free face at the same level as that to be mined. Figure 21 shows the free face between levels 686-700, on which the spatial variability of the foliation orientation along the strike has been determined from the photogrammetric survey and then used in the blast design.

Usually, at the mine site, when mining footwalls, the bench face angle is based on measured orientation from the bench above. As foliation orientation is locally variable along the strike and depth, this practice presents the risk of undercutting the foliation. Trim blasting parallel to the foliation with a free face was therefore recommended. This provided an opportunity

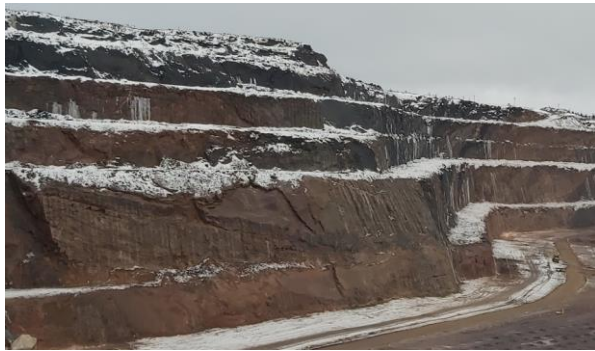
Figure 22. Final wall

Figure 22 shows the final wall built. It presents good blast performance compared to the bench above by reducing rockfall hazard through a cleaner bench face. Final wall design refinement is still ongoing at the mine site.

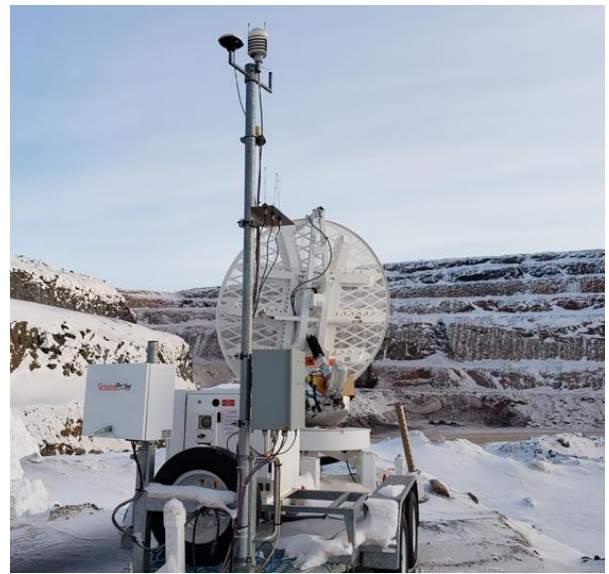
Figure 23. Slope Stability Radar monitoring the southeast wall

Figure 23 presents the SSR monitoring of the southeast wall. A project-specific trigger action response plan was developed. Alarm thresholds were set, and an intervention plan following radar alarms was implemented as part of controlling the slope instability risk. The current deformation rate of the slope is used as the reference velocity. It corresponds to the green alarm, indicating a normal continuation of mining operations. Any increase of 25% in velocity corresponds to the yellow alarm, resulting in increased geotechnical inspections and preparation for pit evacuation. Any increase of 50% corresponds to the orange alarm, resulting in the evacuation of the pit. Any increase of 75% corresponds to the red alarm, resulting in the pit being closed until the slope is stable again.

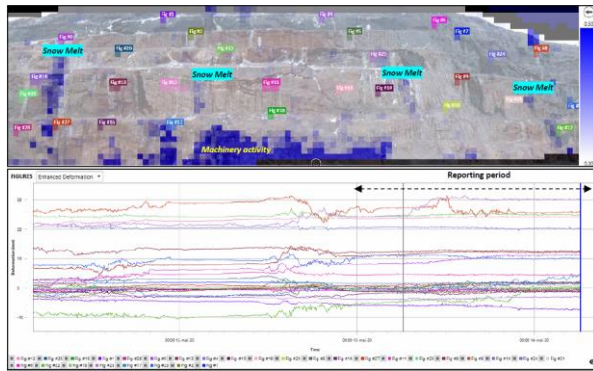
Figure 24 shows the radar image of the southeast wall. It can be seen that the deformation trend is still linear for the selected control points that are used for the long-term deformation analysis, and the wall is stable. The vertical steps in the deformation plot are residual errors due to atmospheric anomalies that occurred during short periods of time.

Figure 24. Radar image and deformation plot
