Monitoring the performance of wood blocking system for remediating timber piles in the Arctic

Chao Liu

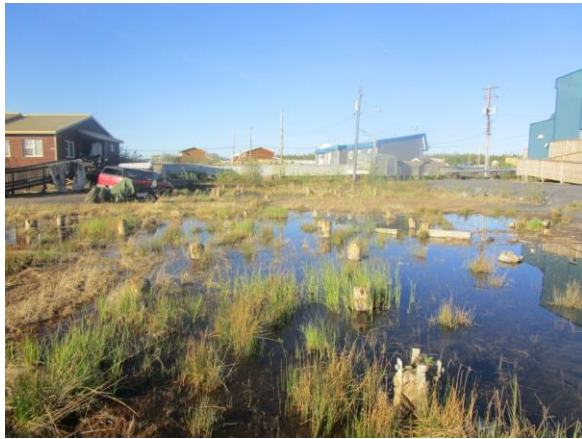
viability of buildings, the safety of occupants, and absorbent costs. For example, Figure 1 shows that two residential houses were demolished because most of the underpinning timber piles were severely damaged.

Figure 1. Timber piles that were severely decayed such that the houses had to be demolished. Photo taken in Inuvik, NWT.

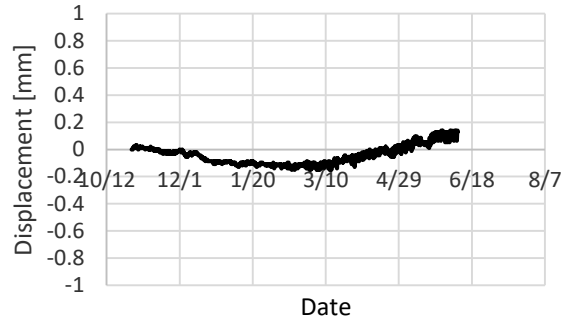
Figure 10. Some typical data represented by the LPs: (a) LP 1; (b) LP 5

LP 1 (Figure 10a) is less than 0.2 mm, which means this part of the building is stable and the beam is well supported by the timber pile. LP 2 (Figure 12-a) indicates a bigger movement than LP 1. As these two sensors were located in the same row which has no wood blocking, it possibly implies that the beam on the timber pile mounted with LP 2 shifts a little to the slope though it is very marginal. LP 3 (Figure 12-b) has the same trend as LP1. LP 4 (Figure 12-c) shows a negative displacement of 0.6 mm right now, while it kept decreasing in winter months and bounced back as the spring came. It seemed that the freezing of the ground in winter made the horizontal movement of the pile as big as -1.3 mm while the ground temperature went up in spring it became stable around -0.6 mm. LP5 (Figure 10-b) shows a fluctuation from 0.6 mm to 2.5 mm in winter. Its value was positive in this period which means there was a gap between the blocking and the beam. The ground was frozen in winter. Ice lens formed in the soils around the wood blocking and the water beneath the wood blocking might have been absorbed by the ice, which caused the shrinkage of the natural soil under the gravel pad. Thus the gravel pad around the wood blocking subsided. When spring came, the ice melted and water refilled the voids in the natural soil so that the gap was becoming smaller. Figure 12-b shows a quite big change in May that the LP was -3 mm. It could be due to the reconstitution of the voids in the natural soil. After the freezing and thawing, the voids in the natural soil increase. These extra voids were filled with melting water and thus the soil expanded. As the summertime comes, the water in these voids decreases so that the vertical movement gets to -1 mm. LP 6 (Figure 12-d) shows a fluctuation between -0.5 mm and 0.5 mm. In winter the beam moved towards the northeast and in spring it moved towards the opposite (the trench).

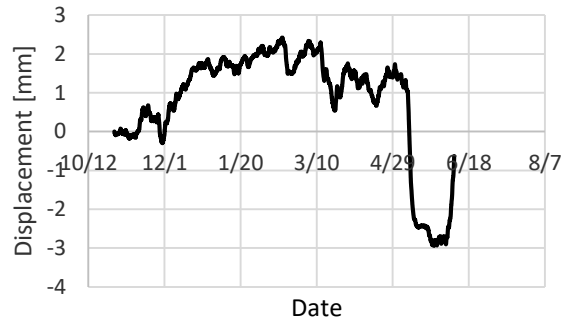
b

The data measured between October 2019 and June 2020 show that the vertical and lateral movement of the building is at a magnitude of 1 mm, which is considerably small for such a large building structure. The settlement measured at one wood blocking is alarmingly 3 mm; this value implies that a gap may be formed between the wood blocking wedge and the building floor beam underpinned by the wedge. As the inspection system went through winter and spring, it strongly suggested that the temperature change in the ground had a significant impact on the behaviour of the sensors. The gap may be caused by the settlement or sliding of the wood blocking due to the freezing and thawing of the ground; however, the actual reason may be discovered by a site visit.

1) Most of the movement was in a small magnitude. When the displacement of the wood blocking reaches 3 mm and fluctuates, the wood blocking may need more attention. A manual adjustment of the wood blocking wedges may be required.

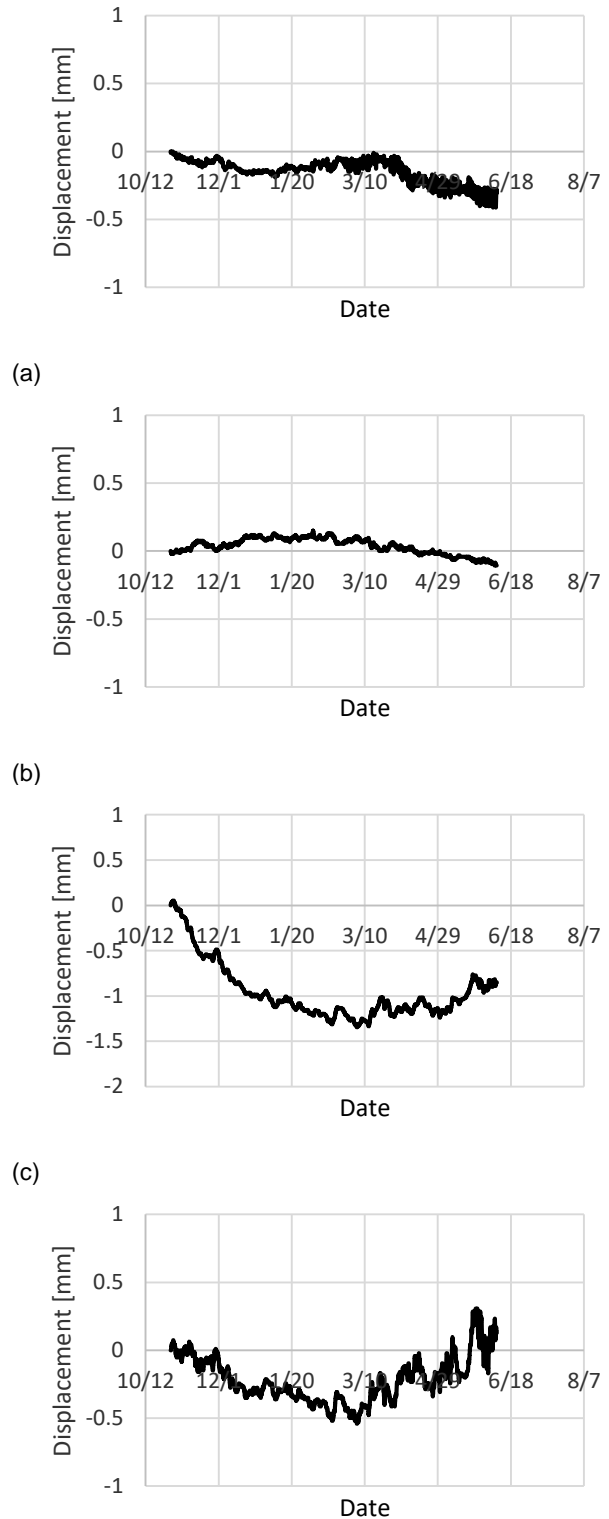
The performance of LP5 and LP6 are of significance as they represent the movement of the blocking. If the displacement of LP5 and LP6 continue to change, a visual inspection of the pile or wood blocking needs to be done to eliminate any potential risk.

(a) (b) (c) (d)
Figure 12. LP readings in various locations: (a) LP 2; (b) LP 3; (c) LP 4; and (d) LP 6
