Historical aerial photographs and digital photogrammetry techniques to investigate the development and evolution of the Chin Coulee landslide in Alberta

Evan Deane, Renato Macciotta & Michael Hendry
Department of Civil and Environmental Engineering – University of Alberta, Edmonton, AB, Canada
Chris Gräpel
Klohn Crippen Berger Ltd., Edmonton, AB, Canada
Roger Skirrow
Alberta Transportation, Edmonton, AB, Canada

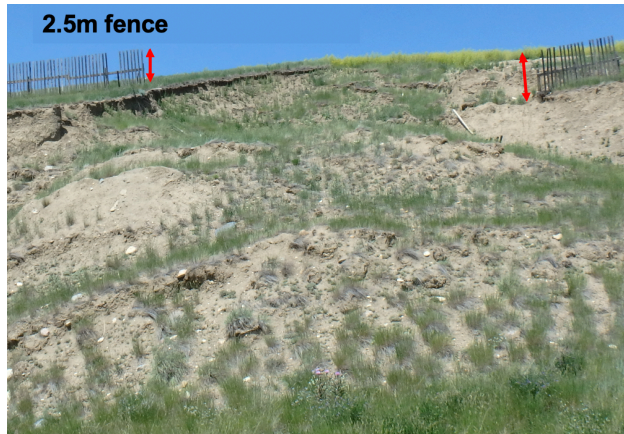
Figure 13 View of the upper half of the Chin Coulee landslide showing a 2.5m high fence as reference scale for the dimensions of the back scarp

Figure 12 indicates considerable loss of material in the upper half of the slope of approximately 4 m between 1982 and 2019. The order of magnitude of this change is confirmed by inspection of the landslide scarp when compared to a 2.5 m high fence (Figure 13). Although differences in resolution and accuracy between the models, this comparison increased the confidence in the
