## The Use of X-ray to Investigate Clay Shale Within a Landslide

Wallin, K.A., & Hendry, M.T.

*Department of Civil and Environmental Engineering  
University of Alberta, Edmonton, Alberta, Canada*

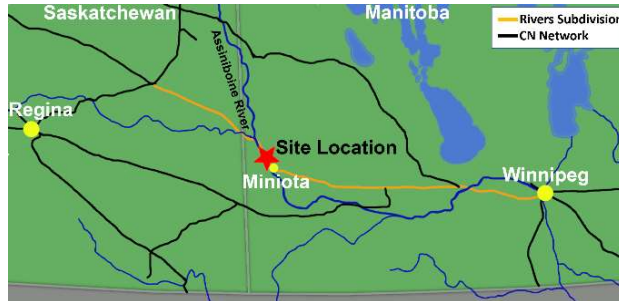
Figure 1. Site location.

In August 2019, a geotechnical investigation was completed at Mile 184.4 of the Rivers Subdivision within the slide mass of a slow-moving landslide affecting CN's Rivers subdivision near Miniota, Manitoba (Figure 1). A continuous core sampling technique was applied at the site where samples were collected directly into plastic liners for preservation purposes. Samples were then transported to University of Alberta facilities where they were scanned using a medical grade X-ray Computerized Tomography (CT) scanner to observe and log core sample features. Images generated were then further utilized to plan a laboratory testing program.

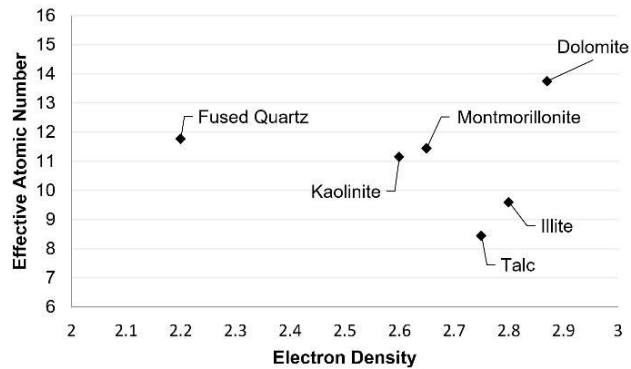
Figure 4. Example calibration materials for clay shale.

Scanning materials at two different energies results in a system of equations with six unknowns. A linearized approximation of these values can be determined by scanning three calibration samples of known density and atomic number. The calibration samples should be chosen such that density and atomic number are close and that their values 'surround' minerals of interest. An example is shown in Figure 4 where fused quartz, dolomite, and talc samples would be used to calibrate a clay shale sample expected to contain common types of clay (kaolinite, montmorillonite and illite).

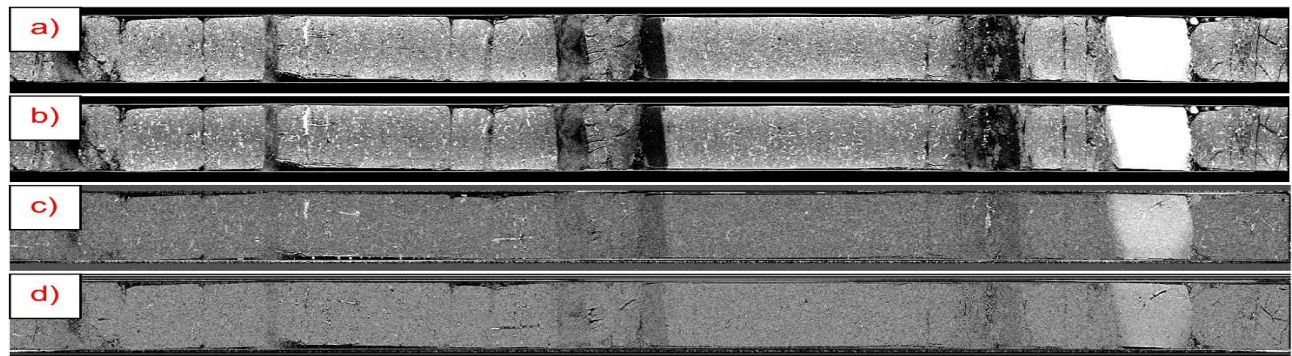
Figure 5. Example of Dual Energy scan images from Mile 184.4 Site: (a) low energy whole core scan, (b) high energy whole core scan, (c) reconstruction based on atomic number, and (d) reconstruction based on bulk density.

Although dual energy scanning provides insights into the effective atomic number and electron density of materials, additional costs of re-scanning core sections and increased data processing requirements offset benefits when compared to whole core scanning. Figure 5 illustrates four images generated from a dual energy scanning process. The whole core scans shown in a) and b) provide clearer insight into the layering present in the core run, whereas c) and d) simply indicate that the atomic number and bulk densities of the materials may be closer than expected when looking at the whole core scans.

Additionally, techniques have been developed to correlate greyscale or Hounsfield Units (HU) output by medical X-ray scanners to bulk densities for fine grained soils. Using these correlations and then identifying layers using greyscale images provides the engineer with similar information at a reduced cost and effort. Dual energy scanning may not provide enough additional value to be a viable slope stability assessment tool.

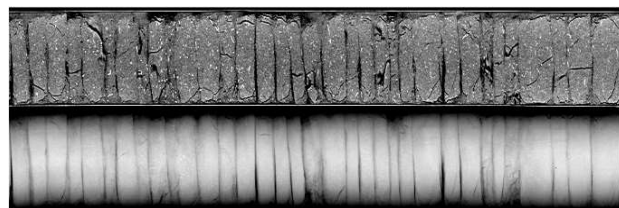
Figure 7. Example of mechanically damaged core.

By examining the images obtained from whole core CT scanning, zones of interest can be effectively targeted for a laboratory testing program while avoiding non-essential zones, saving both time and money. CT images can also illustrate small fissures or zones where core samples may have been damaged during the sampling process. Mechanically damaged core samples are typically avoided when completing strength characterization tests (i.e. triaxial testing). An example of mechanically damaged core from the Mile 184.4 site is provided in Figure 7. Much of this core contains mechanical damage resembling that of core diskings. Through whole core CT, this sample may still provide valuable characterization information, but would generally not be considered viable for strength testing.

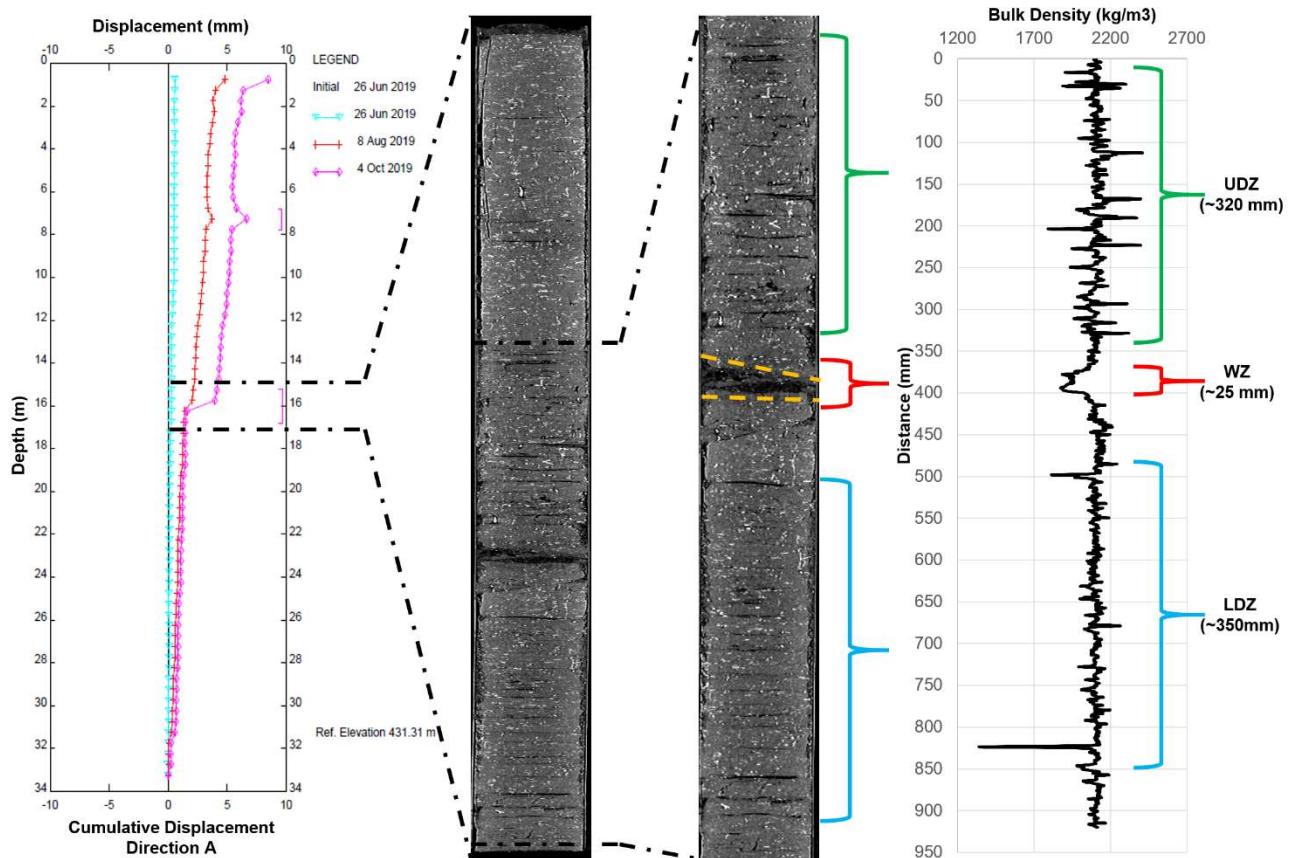
Figure 8. Example assessment of core section based on movement zone observed in slope inclinometer.

Having the cores preserved throughout the scanning process also affords the engineer time to observe slope movement development in the instrumentation installed at the site. Movement zones observed within the slope inclinometers can be targeted using whole core CT scanning to save on scanning costs. Figure 8 shows a

preliminary assessment of a core sample found within the movement zone at Mile 184.4. A movement zone was noted at a depth of about 16 m below ground surface. The core run which correlated to this depth can then be examined. The core is relatively intact in the upper third. What appear to be natural fractures can be observed in the lower two thirds. If the engineer further examines the damaged section of the core and plots it against the correlated bulk density it can be observed that there appears to be three main zones, a weak layer with a lower bulk density than the surround materials (defined as the weak zone or WZ), an upper damaged zone (UDZ) above the WZ and a lower damaged zone (LDZ) below.

The UDZ appears more fractured than the LDZ, extending about 320 mm above the WZ. Fractures observed in the UDZ occur in intervals increasing from about 12 mm near the WZ to 70 mm moving up along the vertical core axis. The LDZ extends about 350 mm below the WZ. This zone appears to visually show signs of cracking/fractures; however, based on a review of the bulk density versus depth plot, there only appears to be two fractures, one approximately 100 mm below the WZ and another about 325 mm lower. Although there appear to be several fractures along the LDZ, based on the bulk density chart these features do not persist through the cross section of the core. This analysis could then indicate that the movement is generally occurring within and above the identified WZ.

A high-level qualitative analysis comparing bulk density versus water content of the core can also be completed. This is based on the interpretation that the darker bands on the scans have a lower density due to the material having a higher water content. Three assumptions are required for this: the material does not vary in composition along the core run (i.e. is homogeneous except for water content); a specific gravity of the material; and, that the material in-situ is under saturated conditions. Then applying the interpretation with phase relations, the average bulk density and correlated water contents can be determined as shown in Table 2. If considered viable, the WZ would then be assessed at a fully-softened strength as defined by Skempton (1977). As a caveat, the author/engineer still need to verify these assumptions and results with further laboratory testing of the core.
