Terrestrial laser scanning (TLS) deformation monitoring of a high-fill embankment in the Arctic

Dylan Stafford, Earl Marvin De Guzman, Samuel Kaluzny, & Marolo Alfaro
University of Manitoba, Winnipeg, Manitoba, Canada

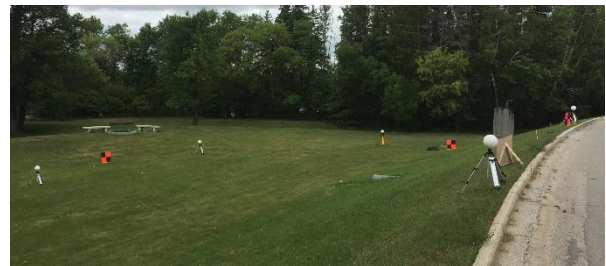
Figure 3. TLS calibration test for site-scale survey.

The third TLS calibration was designed to test the scanner's ability to identify targets and register scans for a survey similar to one that would be conducted on-site. The test was conducted next to a 5 m high road embankment (Figure 3). Five scans were performed with the sphere and checkerboard targets set up at the distances and angles planned for the on-site surveys. Although not all targets were able to be marked during processing, there were enough targets for accurate registration of all scans. Therefore, the survey setup was deemed acceptable and used as a reference to determine the final design of the on-site surveys.

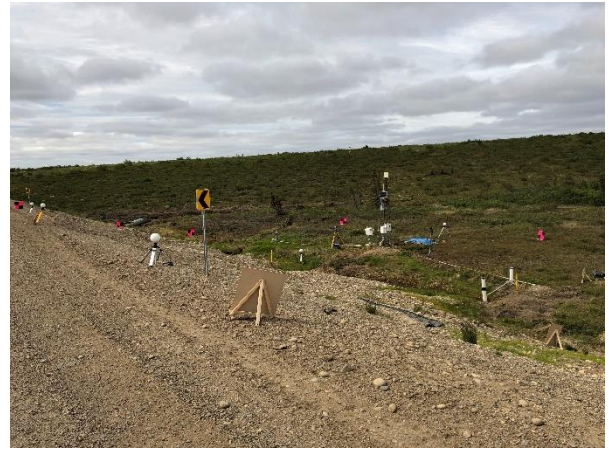
Figure 5. 2019 TLS survey at the research embankment west slope.

checkerboards for each slope, with an RTK observation times of 30 seconds at checkerboard centres. Checkerboards at ground surface were set up on the stands at a 75° standing angle to optimize the viewable surface area for scans completed along the embankment toe and shoulder. Checkerboards on the shoulder were set up vertical. Since none of the targets remained in the same position for scans of both slopes, the two slopes could not be registered together and two point clouds were generated. In 2019, six spheres and ten checkerboards were used on each slope, and the RTK observation time was increased to 60 seconds at each checkerboard to reduce positional measurement errors. Additionally, six targets (two spheres and four checkerboards) that were set up along the road surface remained in position and were scanned for both slopes (Figure 4). This allowed the entire embankment to be registered into one point cloud. Figure 5 shows the TLS survey setup at the west slope in 2019.

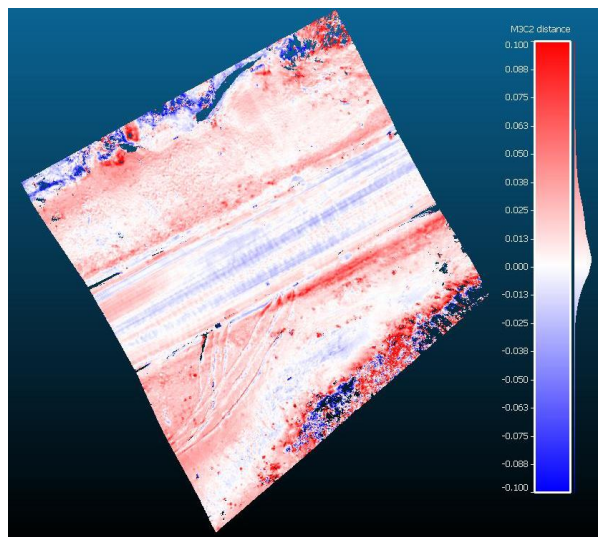
The vertically shifted point cloud comparison (Figure 7) showed positive change (red) deformations at the upper-slope of both sideslopes. At the lower-slope, the west slope (facing northwest) showed positive change, which could have been lateral spreading, and the east slope (facing southeast) showed negative change (blue), which appeared to be toe subsidence. The non-uniform behaviour on the slopes and relatively large positive change at the upper-slopes did not seem realistic, though. These observations led to the rotation alignment of the point clouds, as discussed.

Figure 7. TLS M3C2 deformation after vertical shift (scale: ± 100 mm).

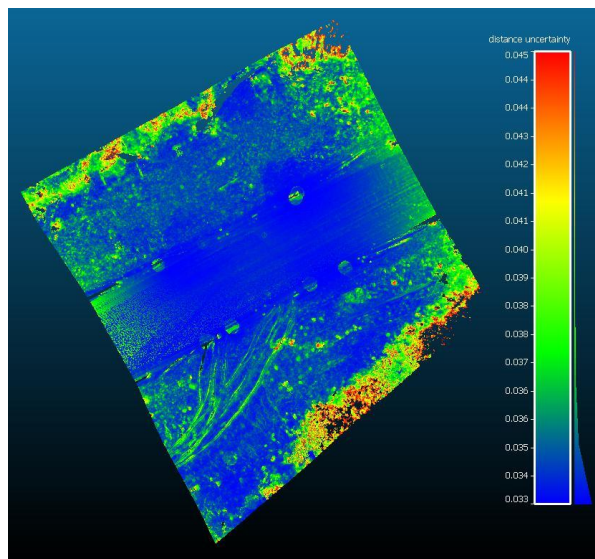
It is important to consider the deformation uncertainty estimates (i.e. LoD) and significant change outputs of the M3C2 comparisons. LoD estimates for the M3C2 comparisons (Figure 9) were 33–40 mm on the embankment. LoD estimates were higher along the toes (~ 45 mm) due to vegetation. The significant change estimates for the M3C2 comparisons (Figure 10) show that almost the entire embankment can not be considered actual change—red points represent significant change where deformation is greater than the LoD. If surface roughness was ignored and only registration error (*reg*) was considered for calculating

Figure 9. TLS M3C2 LoD estimates (scale: 33–45 mm).

LoD (Equation 1), LoD for the TLS comparisons would be 33 mm. Comparing this value to the computed LoDs demonstrates the large influence of *reg*. Surface roughness of the embankment only contributed a maximum of roughly 5 mm to the LoD. The large *reg* values and inconclusive significant change results were due to the high GCP position errors from the RTK survey.
