GeoVirtual
2020 September
14-16
Resilience and Innovation

Sustained Capacity of Friction Piles in a Clay Deposit Treated by Electro-Osmosis: Observations over Five Decades

P.K. Chatterji, Murray Anderson, Keli Shi
Thurber Engineering Ltd., Oakville, Ontario
Ken Ahmad
MTO Pavements and Foundations Section, Toronto, Ontario
Tae C. Kim
exp Services Inc., Brampton, Ontario
(formerly with MTO Pavements and Foundations Section)

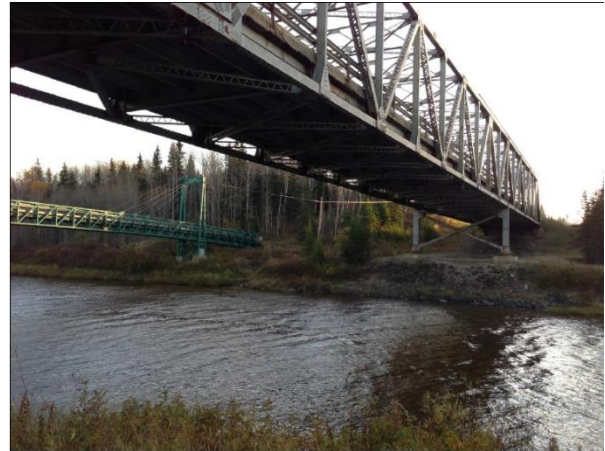
Figure 1. Looking east from west bank of Pic river (2011)

The river channel at the bridge is approximately 67 m wide and 7.5 m deep. The river flows to the south and is relatively fast flowing at this location. Rock fill erosion protection is visible above the river level in the lower parts of the approach embankment and valley slope. A photograph of the site is shown in Figure 1.

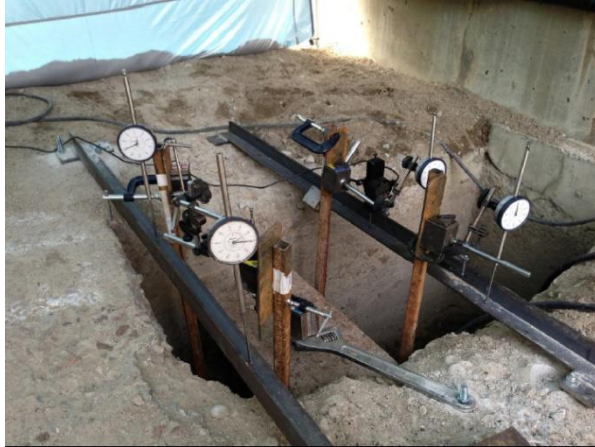
Figure 4. Pile load test set-up at Pile E-16, East Pier

Each pile was loaded to a maximum load ranging from 700 kN to greater than 900 kN and settlement of each pile was recorded at prescribed intervals under each load increment. A photograph of the load test set up is presented in Figure 4.

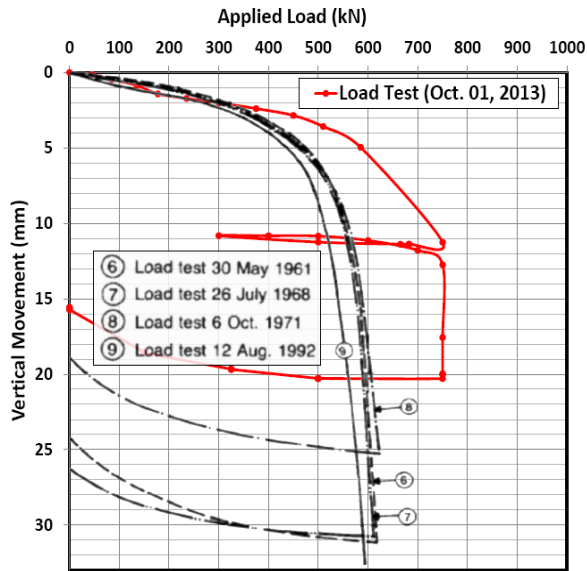
Figure 6. Load deformation curves of East Pier G-5

The results of the static pile load tests on the three piles are plotted on the load-settlement curves in Figures 6, 7 and 8 along with the historical load test curves. A review of the pile load test data indicated the following:

- 1) The interpreted ultimate capacity of Piles G-5 and E-16 at the east pier ranges between 550 and 600 kN.
- 2) The load/deformation behavior of the test piles at the east pier is essentially elastic below 600 kN and the pile settlements are less than 5 mm. The settlement

increased more rapidly with each load increment over 600 kN, reaching a maximum of 19 to 20 mm (indicating pile failure) at applied loads of 690 and 750 kN before the load test was discontinued.

The load settlement curves from the current load tests in Figures 6, 7 and 8 are plotted along with the load settlement curves previously conducted in 1961, 1968, 1971, and 1992. The results indicate that the ultimate pile capacities of all three piles have been maintained and appear to have increased for piles G-5 and E-2.

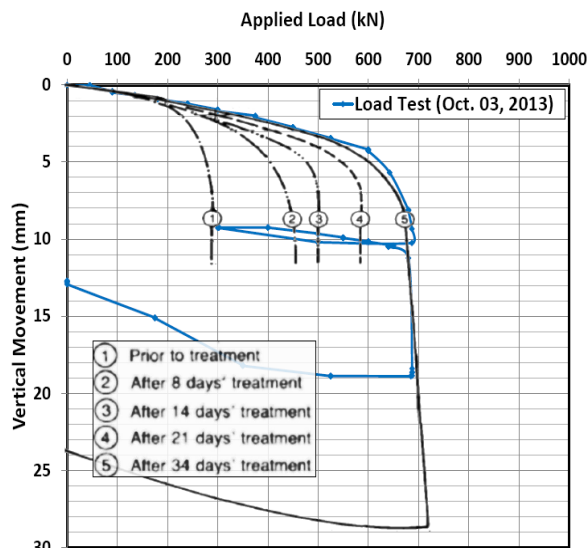
Figure 7. Load deformation curves of East Pier E-16

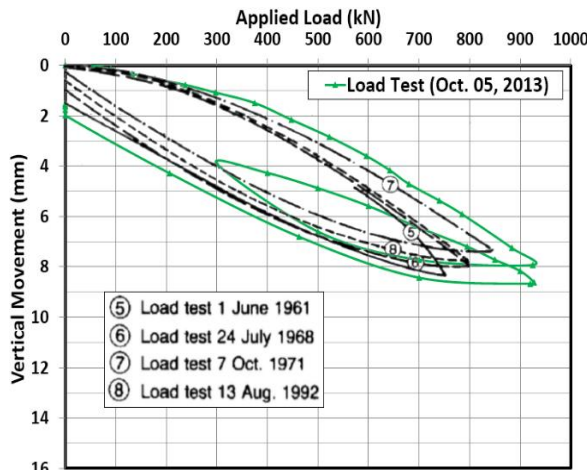
Figure 8. Load deformation curves of West Pier E-2

3) The load test for Pile E-2 at the west pier indicated that the pile did not reach failure at a loading of 900 kN and the pile settlement at this loading was in the order of 8 mm.

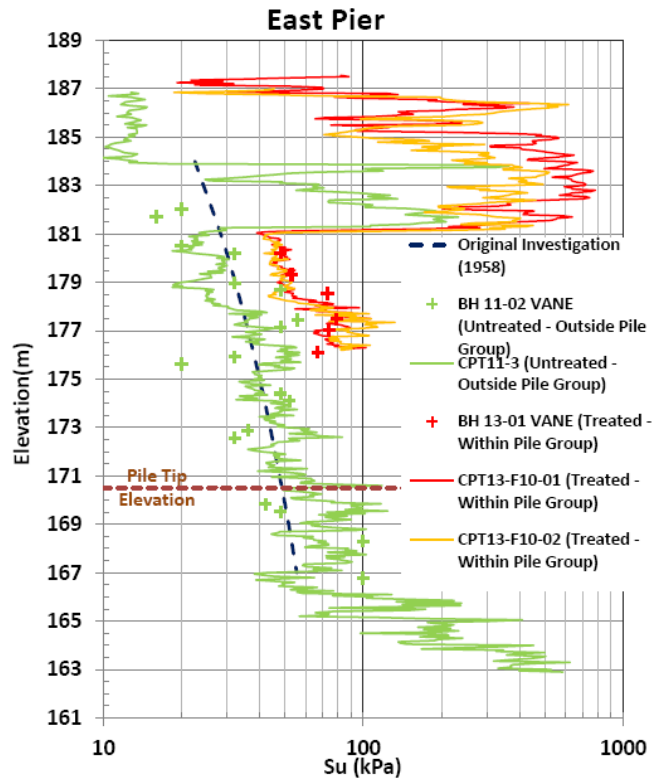
Figure 9. Comparison of undrained shear strengths of untreated clay and treated clay at the East Pier

The results of piezocone tests are presented in Figures 9 and 10. The results of field vane tests indicate undrained shear strengths of the treated clay from 48 to 80 kPa at the east pier and 53 to 75 kPa at the west pier.

Figures 9 and 10 present a comparison of undrained shear strength (S_u) of the untreated clay (outside pile group) versus the undrained shear strength of the treated clay around the piles (within pile group) of the east and west piers, respectively. The average S_u profile from the original 1958 investigation appears very similar to the S_u profile of the untreated clay outside the pile group tested in 2011. At both pier locations, S_u for the untreated clay ranges from 20 to 58 kPa, while the S_u values of the treated clay ranged from 50 to 70 kPa. This data tends to indicate an increase in the clay strength by about 50% after electro-osmotic treatment.

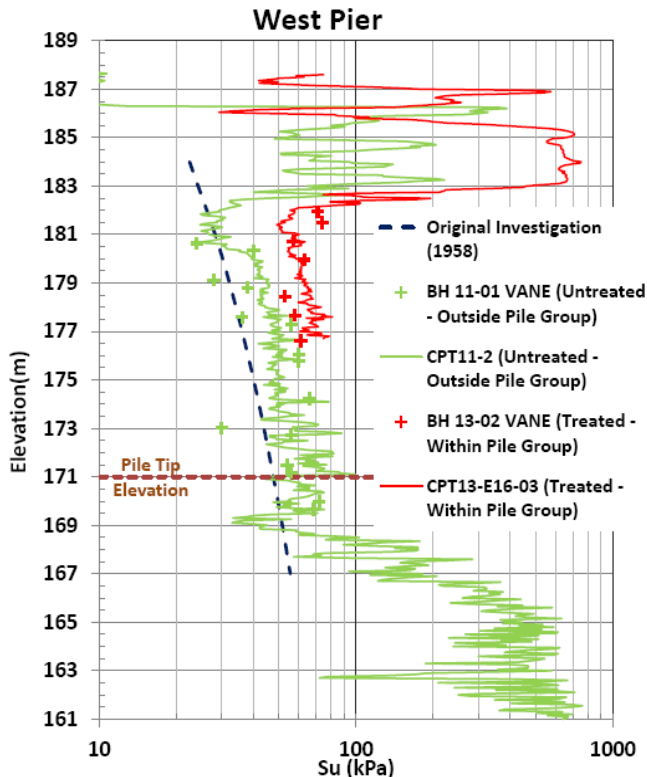
Figure 10. Comparison of undrained shear strengths of untreated clay and treated clay at the West Pier
