Design of deflection berms for small post-wildfire debris flows

David R. Scott & Dwayne D. Tannant
University of British Columbia, Kelowna, BC, Canada

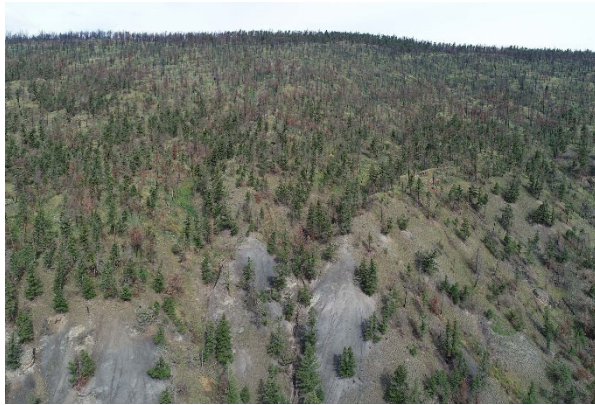
The wildfire in 2017 burned most of the valley side down to Loon Lake Road. Figure 3 shows a view of the watershed above the depositional fan near the bottom of the Bonaparte River valley. The burn severity was high to moderate in the upper watershed, where the forest was denser. The burn severity was low immediately above and on the depositional fan, where the terrain was covered by open forest and grasslands. It is likely that the overland flow initiated in the upper watershed where the burn severity was highest, while sediment bulking occurred lower in the watercourse. In particular, the addition of sediment to the flow may have occurred at lower elevations as runoff concentrated into rills and channels where colluvial material was readily available.

The lower flanks the Bonaparte valley side walls are covered with easily erodible glacial till and post-glacial colluvial materials (Plouffe 2009). The dark coloured fine-grained material on the edge of a poorly defined valley wall terrace seen in Figure 3 is believed to be a veneer of glacial till and the source for much of the materials that were mobilized in the debris flows. Outcrops of bedrock (Cache Creek Complex marine sedimentary and volcanic rock: undivided phyllite, siliceous phyllite, ribbon and massive chert, argillite, tuff, mafic volcanic rocks, serpentinite, limestone, sandstone, conglomerate) are present along and between the watercourses (Schiarizza et al. 1994).

Figure 3. View of the burnt upper watershed looking up the west debris flow channel taken 2 years after the fire

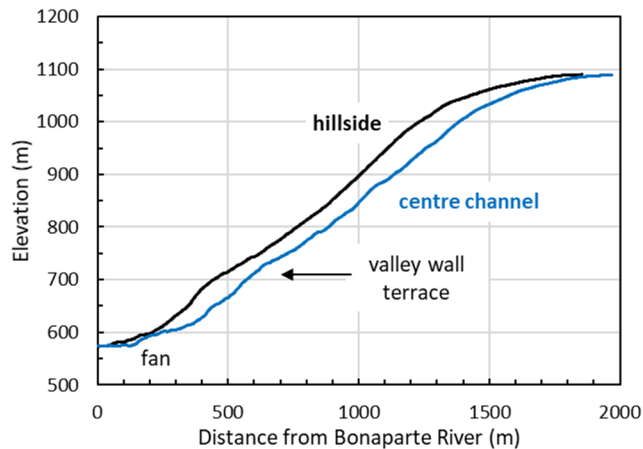
A profile of the centre watercourse involved in the event is shown in Figure 4. The profiles for the other watercourses were similar. The gradient of the middle reaches is approximately 20°. Immediately above the valley bottom depositional fan, the channel gradients are highest where each channel has cut through a terrace flanking the lower sides of the Bonaparte River valley. The characteristics of the three watersheds are listed in Table 1. Based on watershed morphometric research by Wilford et al. (2004) and Holm et al. (2016), each small watershed was a likely candidate for a debris flow because the Melton ratio was higher than 0.5 to 0.6.

Figure 4. Profiles of the centre watercourse channel and the adjacent hillside (2X vertical exaggeration)

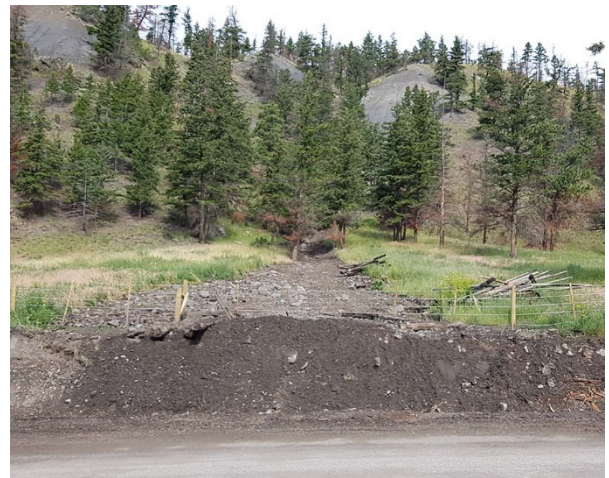
Figures 5 and 6 show the west and centre flow paths viewed looking upstream from Loon Lake Road toward the fan apex. The transported debris was dominated by soils with particle sizes less than 1 cm, although occasional cobbles and small boulders were also present in the debris. These channels only experience flow during high precipitation events or snow-melt. The flows on June 22 were significantly larger than what had been recently experienced. While there was no evidence of prior post-wildfire debris flows, smaller events could have been hidden by new vegetation and the reworking of sediment caused by the June 22, 2019 flows.

Figure 5. West channel looking upstream toward the fan apex from Loon Lake Road

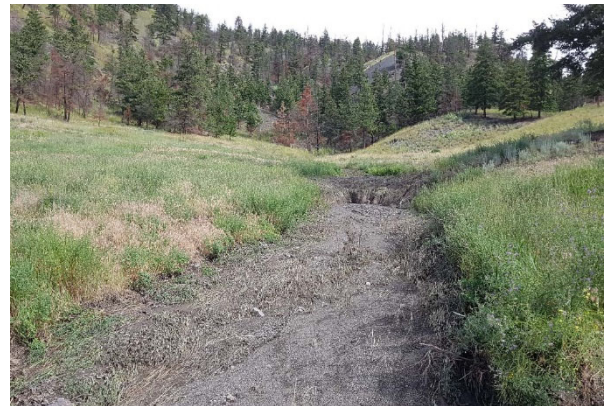
Figure 6. Centre channel looking upstream above Loon Lake Road toward the fan apex

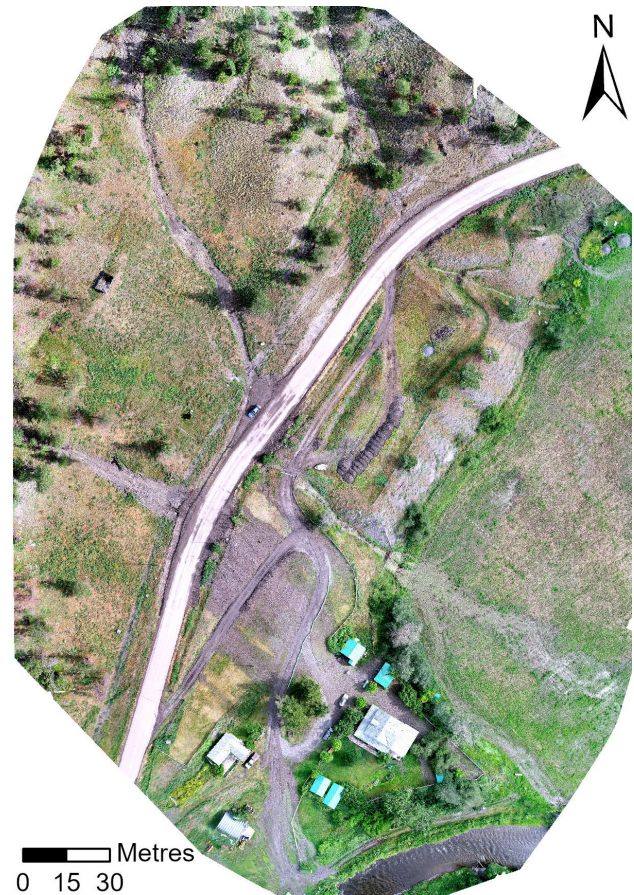
The images and the list of their corrected UTM coordinates were loading into the Structure-from-Motion (SfM) software Pix4D. The camera coordinates recorded in the EXIF header for each image were not used when processing the images. The SfM software was used to generate a dense 3D point cloud and a georeferenced orthomosaic of the fan area (Fig. 7). To create a bare-earth terrain model, it is necessary to disable points representing high vegetation and other objects within the

Figure 7. Orthomosaic of the debris flow site

The orthomosaic (3D geotiff format) and the contour map created from the SfM processing of the aerial images were used to map the paths of the debris flows. Loon Lake Road and smaller roads accessing the buildings and nearby agricultural land have influenced the natural topography and flow patterns across the fan.
