Slope Stability Evaluation and Monitoring of a Sandy Bluff on the Shoreline of Lake Erie

Hugh Gillen and Brennan Bailey
DST Consulting Engineers Inc., Waterloo, Ontario, Canada
Farbod Saadat
DST Consulting Engineers Inc., Mississauga, Ontario, Canada

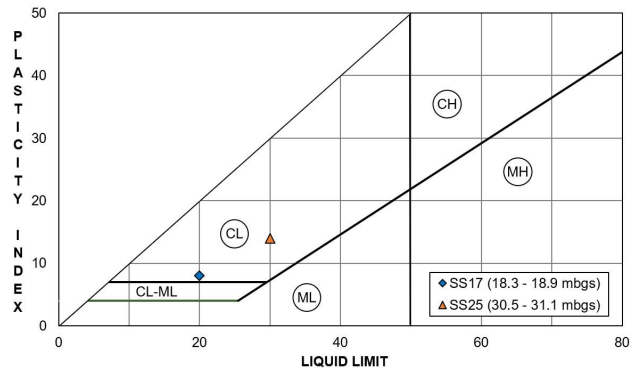
Within the lower sandy silt to silty sand deposit, thin seams of silty clay to clay were observed intermittently. These seams generally ranged from about 0.3 to 0.7 m in thickness, except for one which was approximately 1.8 m thick. Although SPT 'N' values recorded in these sublayers corresponded to a stiff to hard consistency, pocket penetrometer readings for this material corresponded to undrained shear strengths of about 25 kPa (soft to firm). Atterberg Limits tests were performed on two samples of this material and indicated it could be classified as a low plasticity clay (CL). The results of the Atterberg Limits tests are summarized in Table 1 and depicted graphically in Figure 4. Unfortunately, field vane tests and Shelby Tube samples were not obtained for this material.

Figure 4. Atterberg Limits results for selected soil specimens obtained during the drilling investigation.

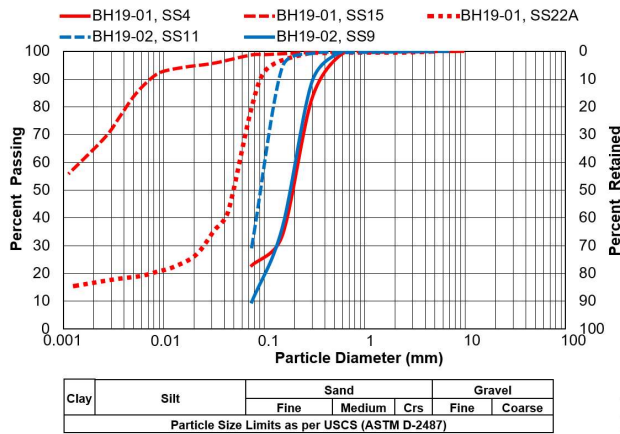
Gradation analyses by sieve and hydrometer were completed to confirm soil descriptions and further characterize the observed subsoils. The gradation results are summarized in Table 2 and depicted graphically in Figure 5.

Figure 5. Grain size distribution curves for selected soil specimens obtained during the drilling investigation.

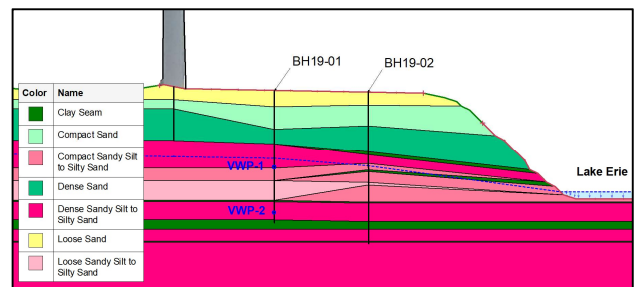
The modelled stratigraphy is shown in Figure 6. Borehole locations are identified by thick black lines, including a historic borehole where the turbine was constructed.

Figure 6. Modelled stratigraphy for the site.
