Tailings dike seepage mitigation through adaptive tailings deposition sequencing

Marion Habersetzer & Yves Boulianne
Golder Associés Ltée, Montréal, Québec, Canada

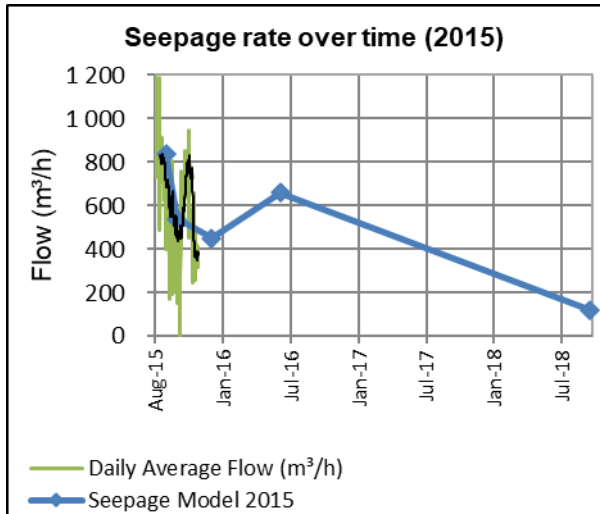
The modelling results were used to compute the expected evolution of the seepage rate over time as the tailings level increases in the facility. The predicted and measured seepage rates as of 2015 are plotted in Figure 2 below.

Figure 2: Seepage data up to the development of the 2015 seepage model and predicted evolution

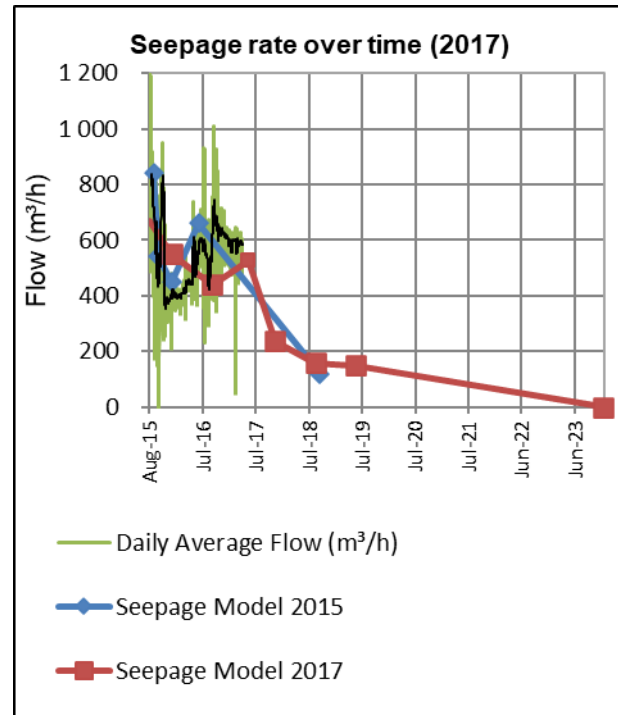
The modelling results were used to update the expected evolution of the seepage rate over time as the tailings level increases in the facility, up to the closure stage. Figure 3 below presents the predictive seepage trend plotted against measured seepage rates at the time of the modelling.

Figure 3: Seepage data up to the development of the 2017 seepage model and predicted evolution

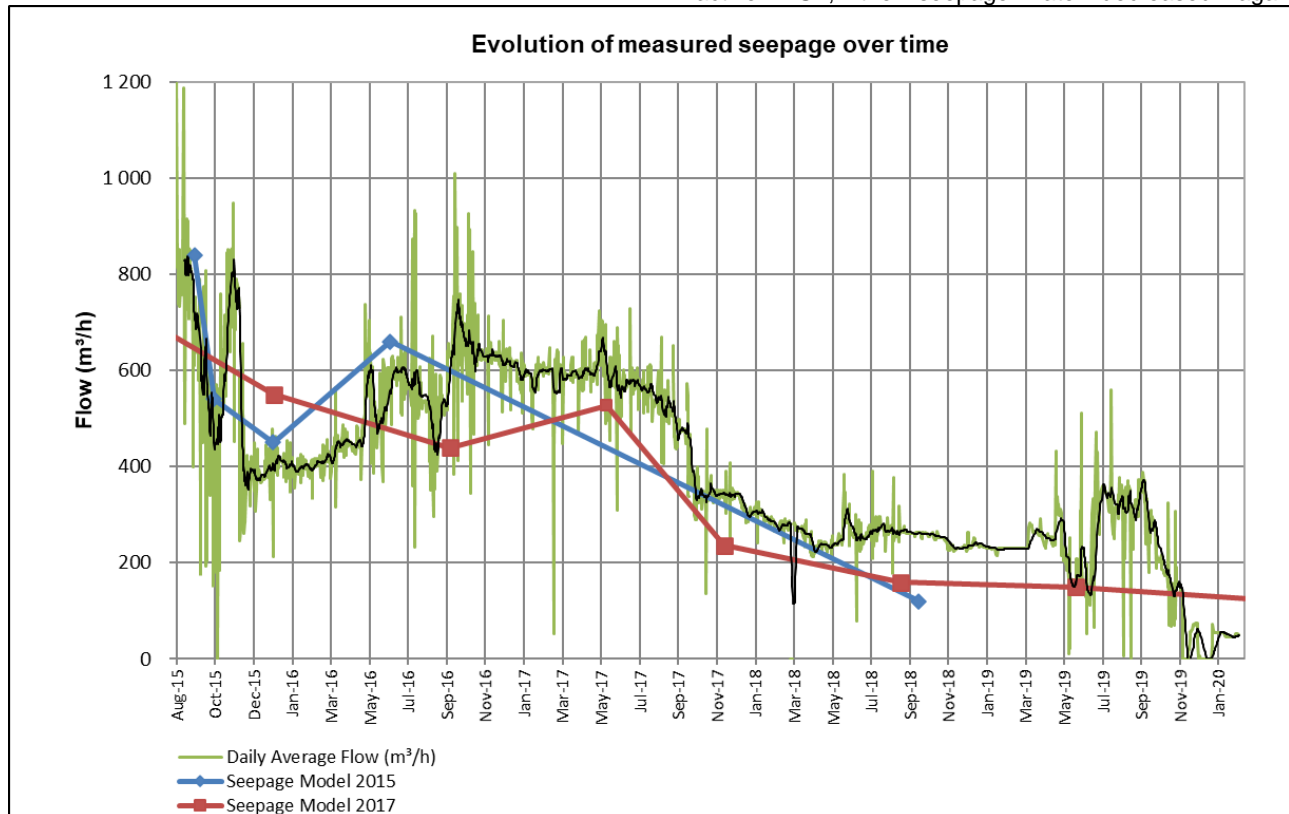
to the higher runoff water volumes that reported to the downstream pond as well as the large inflow into the TSF. At the end of the year 2019, with the onset of winter and the ongoing removal of the supernatant water in the now-inactive TSF, the seepage rate decreased again

Figure 5. Measured seepage over time and computed seepage models

dramatically to about 50 m³/h.

The seepage rate generally exhibits seasonal variations, with an increase in summer as the snowpack melts and frozen pathways thaw and re-open. Small-scale variations in the observed seepage rates can be related to several elements that were not considered in numerical analyses, such as:
