HAZARD ASSESSMENT OF DEBRIS FLOWS INITIATED BY BREACH OF SMALL EARTH DAMS IN BRITISH COLUMBIA

S.A. Mehdizadeh
Englobe, Toronto, ON, Canada
D.D. Tannant
University of British Columbia, Kelowna, BC, Canada
F. Saadat
DST Consulting Engineers Inc., Toronto, ON, Canada

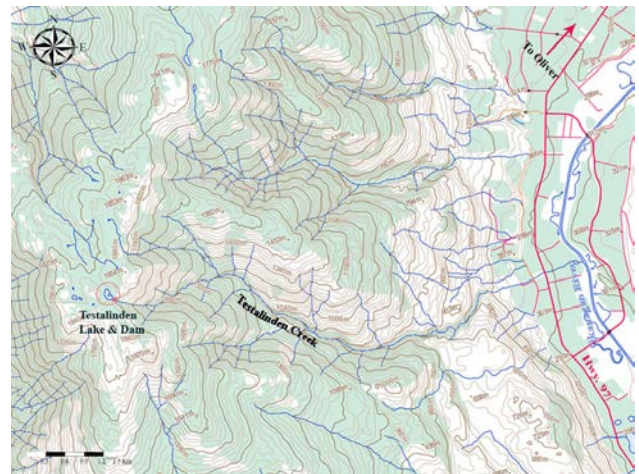
On June 13, 2010, a small earth dam failed by overtopping and breaching on the upper watershed of Testalinden Creek, located south of the town of Oliver, BC (Figure 1). The water released by the breach initiated a debris flow that flowed down to the Testalinden Creek fan. The debris flow resulted in extensive property damage on the Testalinden Creek fan (Everest 2010; Culbert 2010, Tannant and Skermer 2013).

Figure 1. Topographic map of Testalinden Creek
