## Design, Construction and Long-Term Performance of a Major Highway Embankment Reconstructed using Tire Derived Aggregate (TDA)

Bernie Mills  
*Stantec Consulting Ltd., Calgary, Alberta, Canada*

Jared McGinn  
*New Brunswick Department of Transportation and Infrastructure, Fredericton, New Brunswick, Canada*

Hany El Naggar  
*Dalhousie University, Halifax, Nova Scotia, Canada*

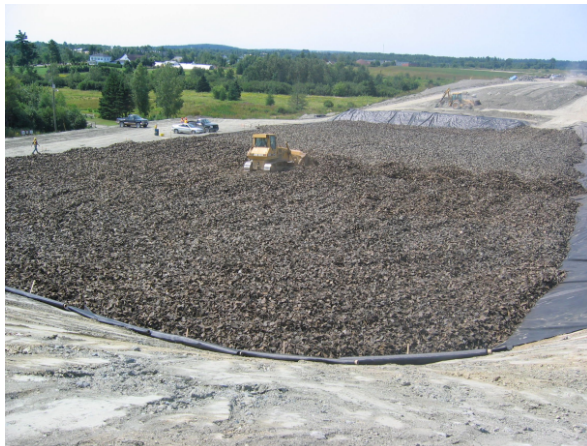
Figure 4. Placement of Bottom TDA Layer, Aug 2007

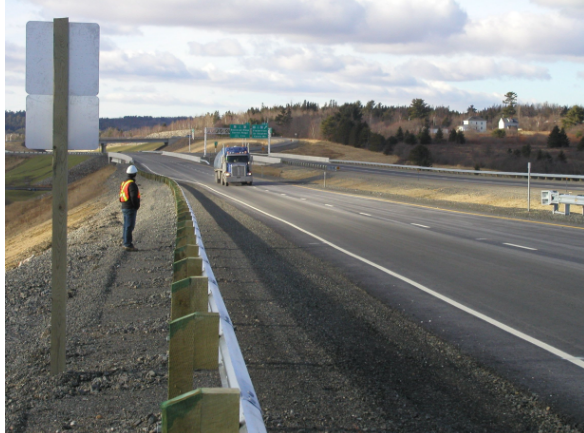
Figure 5. Completed TDA Embankment, Dec 2008

- The completed TDA embankment section of the highway was opened to the public in early December 2008. Figure 5 shows the completed embankment.
- The final asphalt seal layer was placed in May 2009 after majority of time dependent settlement of TDA was completed.
