A case study of reinforced soil slopes in Ontario

Laifa Cao & Scott Peaker
WSP Canada Inc., Toronto, Ontario, Canada

This paper presents a case study of reinforced soil slopes (RSS) along Bathurst Street in the Region of York, Ontario. Six RSSs were designed to be up to 10 m in height and reinforced with geogrids at vertical spacings of 0.6 m for the roadway embankments over three culverts. The slope angle was 70° and slope face units consisted of vegetated geocells. Two years after the RSS construction, the face units of one RSS collapsed after a significant rain event. Field investigation and global stability analysis were carried out. It was found that the possible failure mechanisms of the RSS were the infiltration rate of surface water exceeded the drainage capacity of the RSS and the buildup of hydrostatic pressure exceeded the sliding resistance between the geocells. The failed face units were then reinstalled using the same geocells with the installation of a vertical drainage layer behind the geocells. Following the reinstallation of the face units of the RSS, ground movement monitoring was conducted for all RSSs over the culverts. Field inspection was carried out one ye

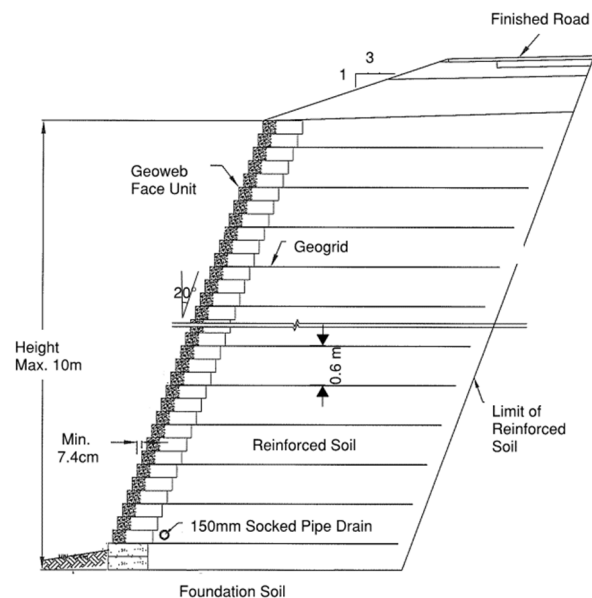
Figure 1 A typical section of designed reinforced soil slope

Based on the soil bearing capacity and parameters recommended in the geotechnical investigation report, a RSS was designed for the wing walls at each CSPA culvert. A typical cross section of the RSS is shown in Figure 1. The RSS consists of:
