Effect of spatial variability of foliation orientation on mining slope design

Joseph Kabuya Mukendi, Richard Simon

Dept. of Civil, Geological and Mining Engineering – Polytechnique Montréal, Montréal, Québec, Canada

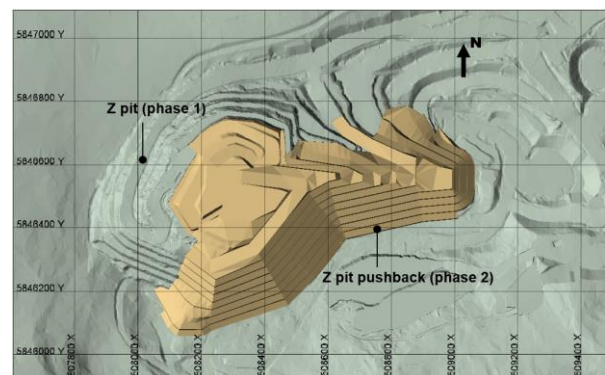
This paper describes the huge challenge of building the southeastern final wall of the Z pit pushback (Figure 1) by mitigating the risk of slope failure caused by spatial variability of the foliation orientation, knowing

that previous mining in this sector of the pit had caused a multi-bench failure 125 m high and 200 m wide.

Figure 1. Z pit phases 1 and 2 (pushback)

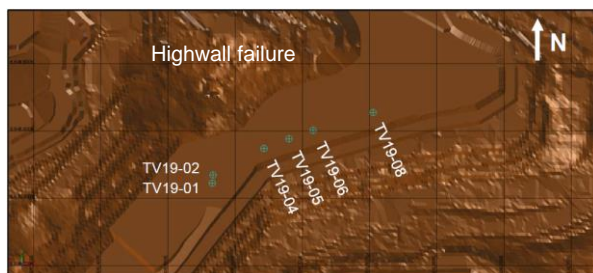
Geophysical surveys were conducted in a series of eight boreholes identified as TV19-01 to TV19-08, all located near the Z pit's southeast wall. The boreholes are all PQ size with a 70° inclination and 160° azimuth (Figure 9).

Figure 9. Locations of televiwer holes

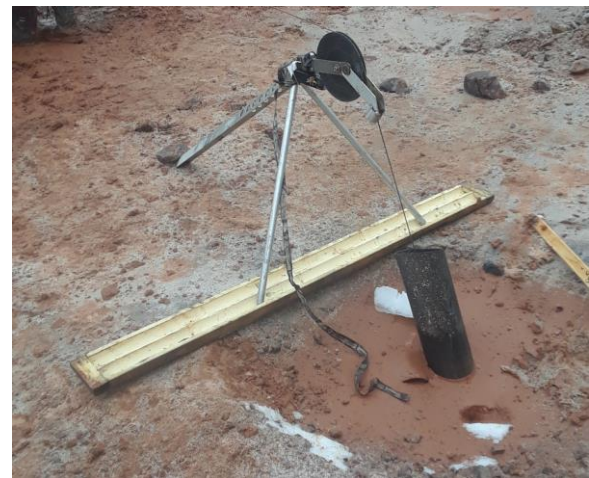
Figure 10 shows televiwer surveys of borehole TV19-08. The tripod and the cable supporting the probe in the borehole are visible. The depths of the logs completed on-site are shown in Table 1. They vary from 26.91 m to 28.90 m.

Figure 10. Televiwer surveys of the TV19-08 hole

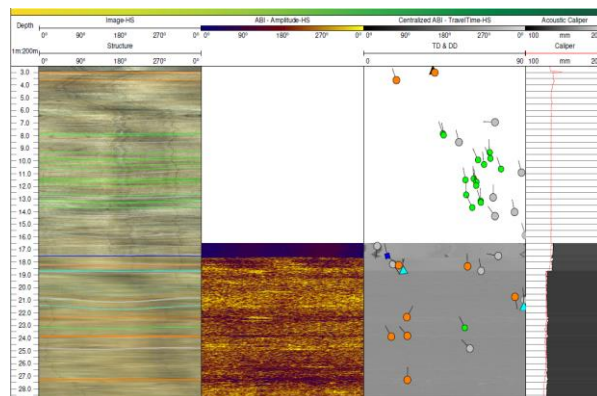
Figure 11. TV19-01 log

The results of this investigation suggest that the plane on which the rupture occurred is not a fault but rather a plan of foliation associated with the bedding, which changes direction in this sector. It can be seen in the figures that it is a set of discontinuities whose orientation varies along the strike of the wall. For TV19-06 hole, the foliation dip seems subvertical although little data has been collected.

The southeast wall is currently being developed assuming that the bedding is facing the wall. The results of these televiewer surveys suggest that the bedding is rather oriented towards the pit and that this wall should be developed as a footwall following the foliation dip. Otherwise, the results suggest that a partially open QR/IF contact, parallel to the wall, is present only at the small eastern area. This was observed only in the TV19-8 hole at 11.4 m. The wall should be monitored during mining operations in the location of this hole.
