Monitoring the performance of wood blocking system for remediating timber piles in the Arctic

Chao Liu

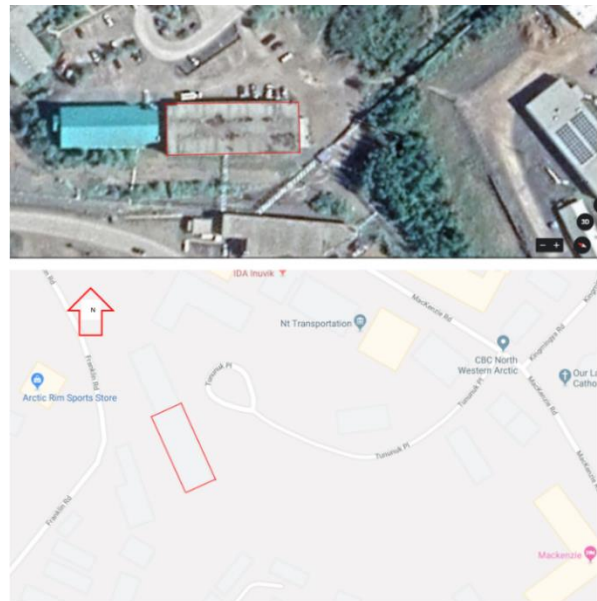
The Mountain View Apartment (Figure 2) is a three-story apartment building to the west of the MacKenzie Road and the east of Franklin Road in Inuvik, NWT, Canada. The building is supported on timber piles (as shown in Figure 3) and the floor beam is 1 to 2 m above the ground surface. The Mt. View is located beside a trench that stretches northwest. The Mt. View building was supported by 128 timber piles (Figure 3).

Figure 2. Plane view of the Mountain View Apartment in a rectangle. Dimensions are not to scale.

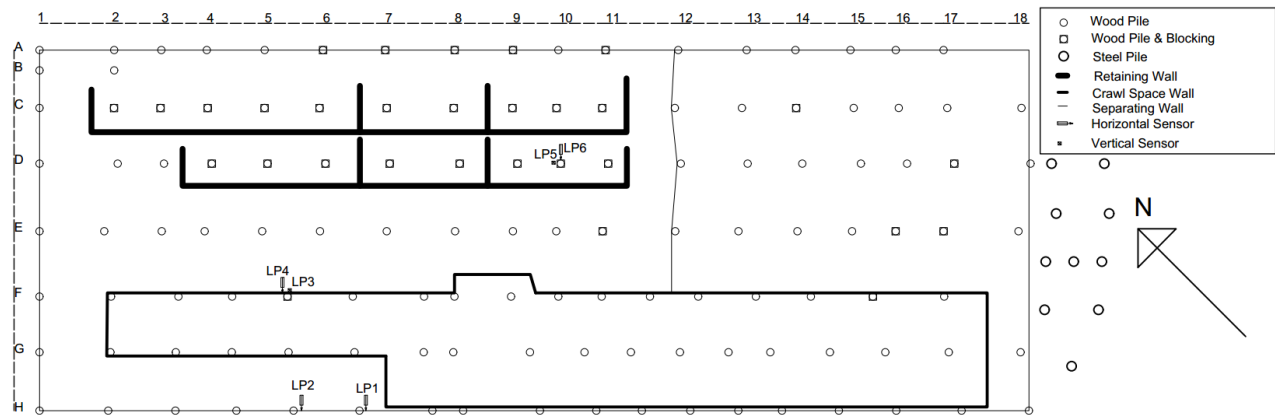
Visual inspection suggested that many piles have suffered partial or full deterioration caused by physical, chemical, or biological actions of the ambient environment. The damaged piles need to be replaced or supported for the safety of the building and tenants. The wood blocking system was adopted by the owner to fix the failed piles and to assure the long-term service of the timber pile foundation. The wood blocking system was built in September 2019 to retrofit selected piles (29 piles in total, shown in Figure 3).

Figure 3. Layout of timber piles, wood blockings, retaining walls, and LPs

Figure 3 shows the layout of timber piles and wood blocking systems. A field inspection of the pile quality conducted in 2019 suggests that the building might have a trend to slip toward the backside (or toward the Northeast direction) of the building, perhaps because the building is seated on a high terrace.

Figure 3 also shows the location and orientation of all LPs. Locations and objectives of all LPs are described as follows in Table 1. Piles in Row A, C, and D have been modified with retaining walls and wood blocking.

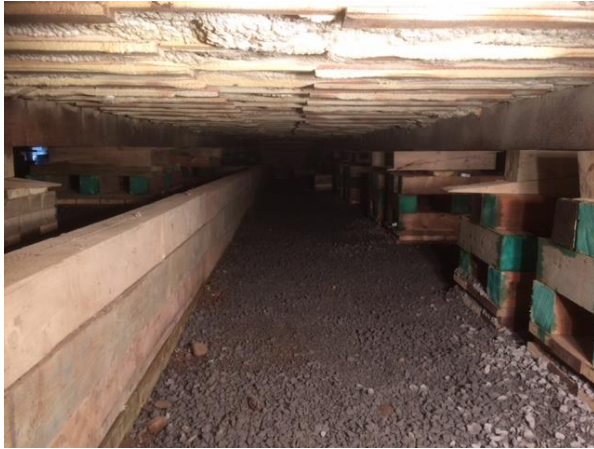
Figure 4. Gravel pad to support the wood blocking system

The Mt. View project's wood blocking system was particularly challenging given the sloped terrain on which the piles were located and hence, the building's superstructure is located. Before the construction of the wood blocking system, the natural topsoil will be removed and refilled with compacted coarse gravels (gravel pad, Figure 4). To ensure the gravel pad remained in place, an extensive wood retaining wall (Figure 5) system beneath the building was designed and constructed. The wood retaining walls allowed for the adequate compaction of the placed gravel, on which the blocking and wedge system would be installed. The wood blockings (Figure 6) are located on the top of the gravel pad. These layered wood pieces consist of a typical wood blocking for one pile. If there is a gap between the building floor beam and the wood blocking, wedges will be placed in between and can be hammered in if a gap forms in the future.

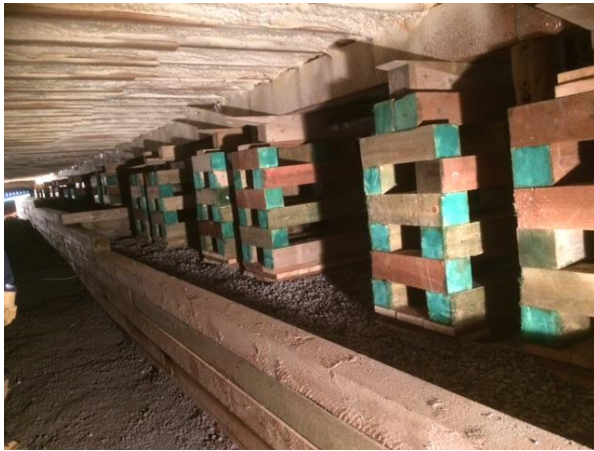
Figure 5. Wood retaining wall to hold the gravel pad

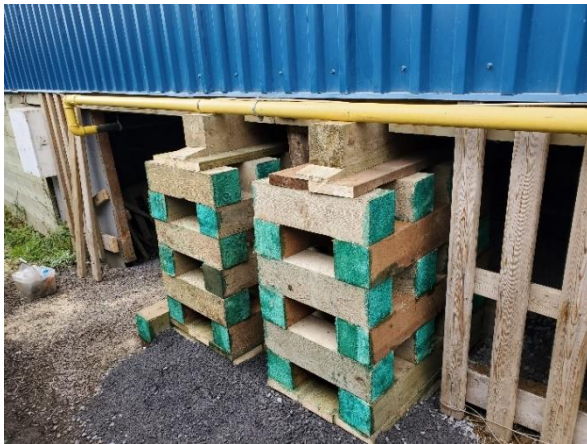
Figure 6. A typical configuration of a wood blocking

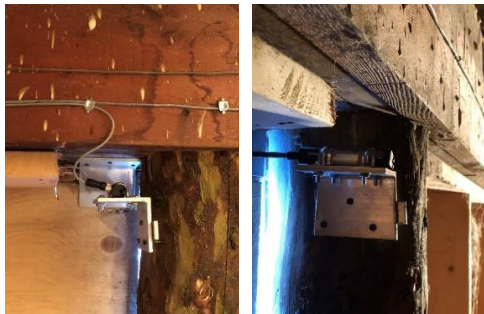
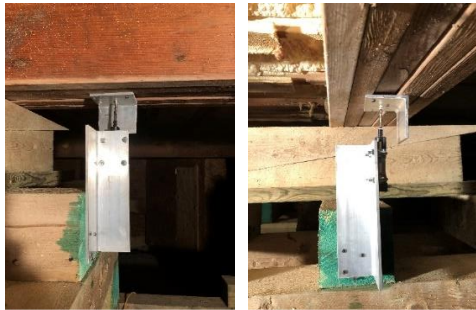
Figure 9. Configuration of the mounted LPs

LP 1,2, 4, and 6 measures the horizontal movement of the beam to the assumed unmoving piles. LP 3 represents the vertical movement of the beam to the pile. And LP 5 indicates the vertical displacement of the wood blocking to the pile. All the LPs were mounted to an aluminum plate firstly, and then the plate was fixed to the beam (Figure 9). All readings are in mm scale and the typical recording was shown in Figures 10 and 11.

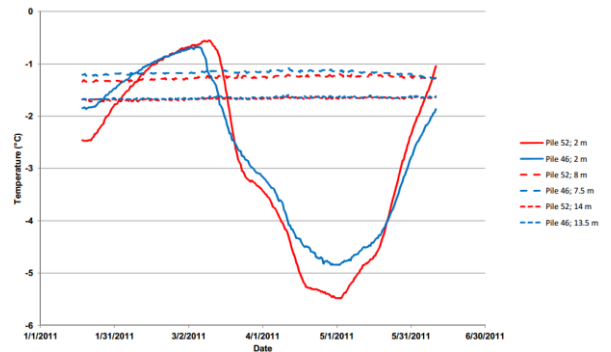
Figure 11. Comparison of Ground Temperatures Under another building at a nearby site in Inuvik, NWT (EBA 2011)

Figure 11 shows a temperature change of the ground at the Western Arctic Center through a year-long time. The temperature deeper than 2 m was stable which indicated that the active layer of this site was around 2 m. The temperature of the shallow surface implied a seasonal
