Settlement behaviour of embankment placed over wash pond sediment

Kevin Lee, P.Eng. & Joseph Yonan, P.Eng.

Tetra Tech Canada Inc., Calgary, Alberta, Canada

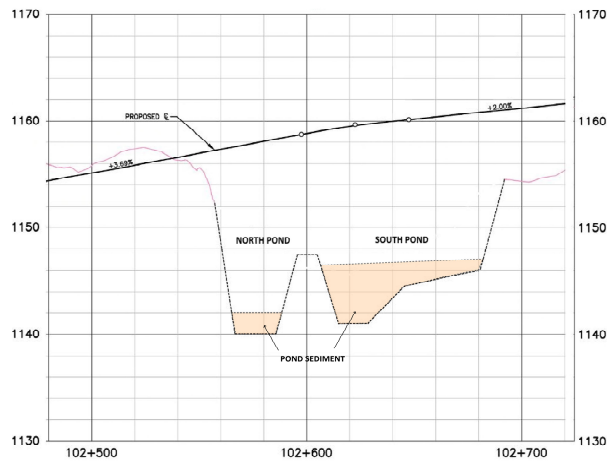
Figure 2. Cross-section of ponds

At the time of construction, the pond sediment varied up to 5 m thick in the South Pond, with the thickest layer located in the north portion of the South Pond. The pond sediment in the North Pond varied up to approximately 1 m to 2 m thick. A cross-section of the ponds and estimated sediment thickness is presented on Figure 2.

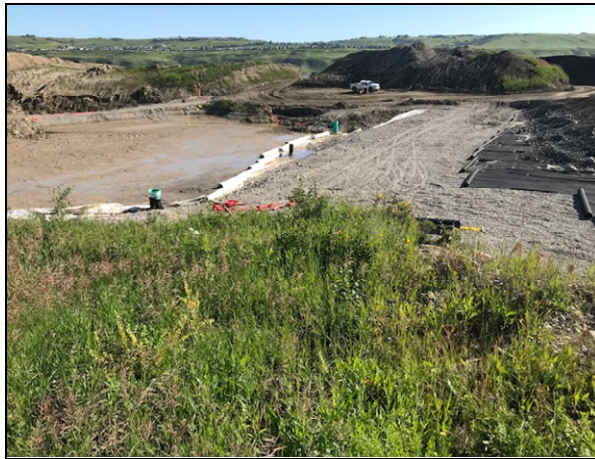
Figure 3. Drainage blanket construction on South Pond

The drainage blanket construction was dependent on the stability of the sediment and was only advanced when safe to do so. Embankment backfill was carried out in tandem with the drainage blanket construction where possible. Embankment backfill was limited to a maximum height of 5 m with a minimum setback of 30 m from the edge of the drainage blanket until the drainage blanket was complete. Figure 3 illustrates construction of the South Pond drainage blanket.

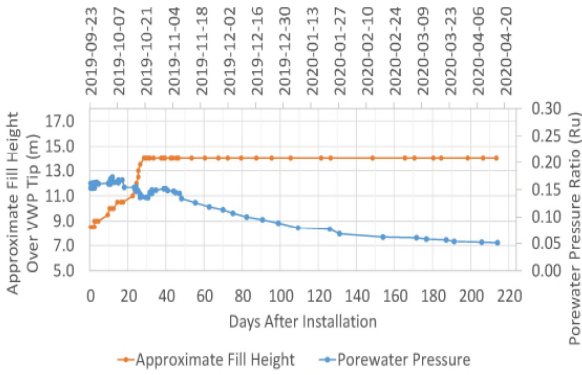
Figure 6. WVP #3 porewater pressure vs. approximate fill height overlying WVP tip

The porewater pressure data readings from VWPs #3 and #4 are presented graphically on Figures 6 and 7, respectively. The porewater pressure is also plotted against the approximate fill height overlying the VWP tip.

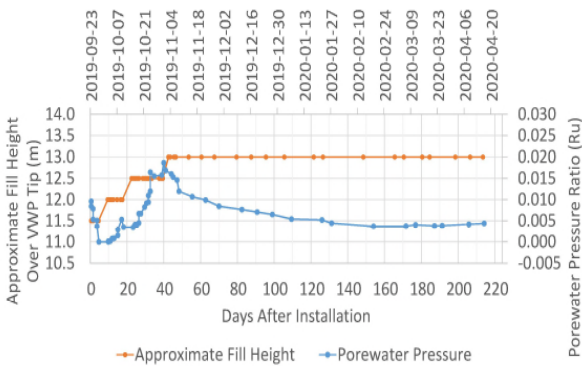
Figure 7. WVP #4 porewater pressure vs. approximate fill height overlying WVP tip
